PHOTOGRAPHS

PHOTOGRAPH LOG

SITE: Former Northwest Regional Hospital Property

DATE: January 23-24, 2012

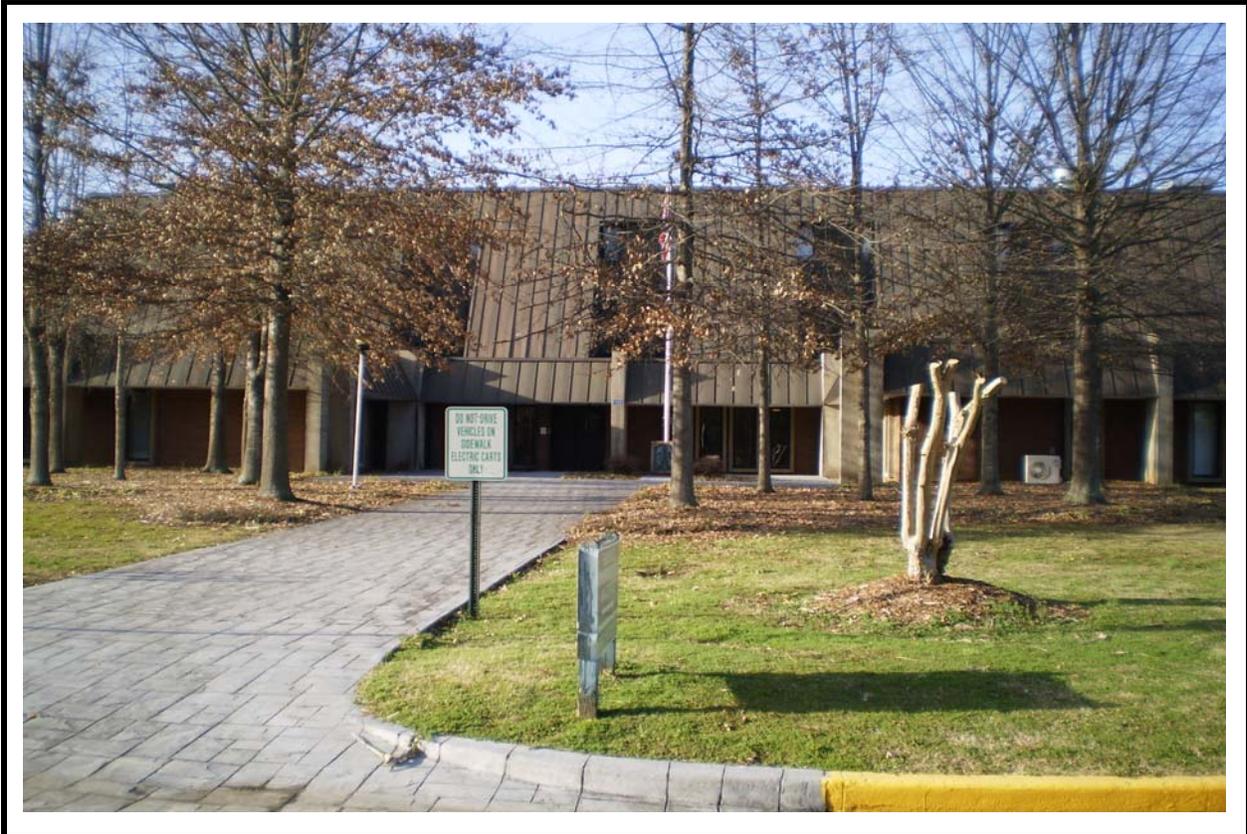
Photo 1

View of Building 103 - Administrative offices and Main Hospital

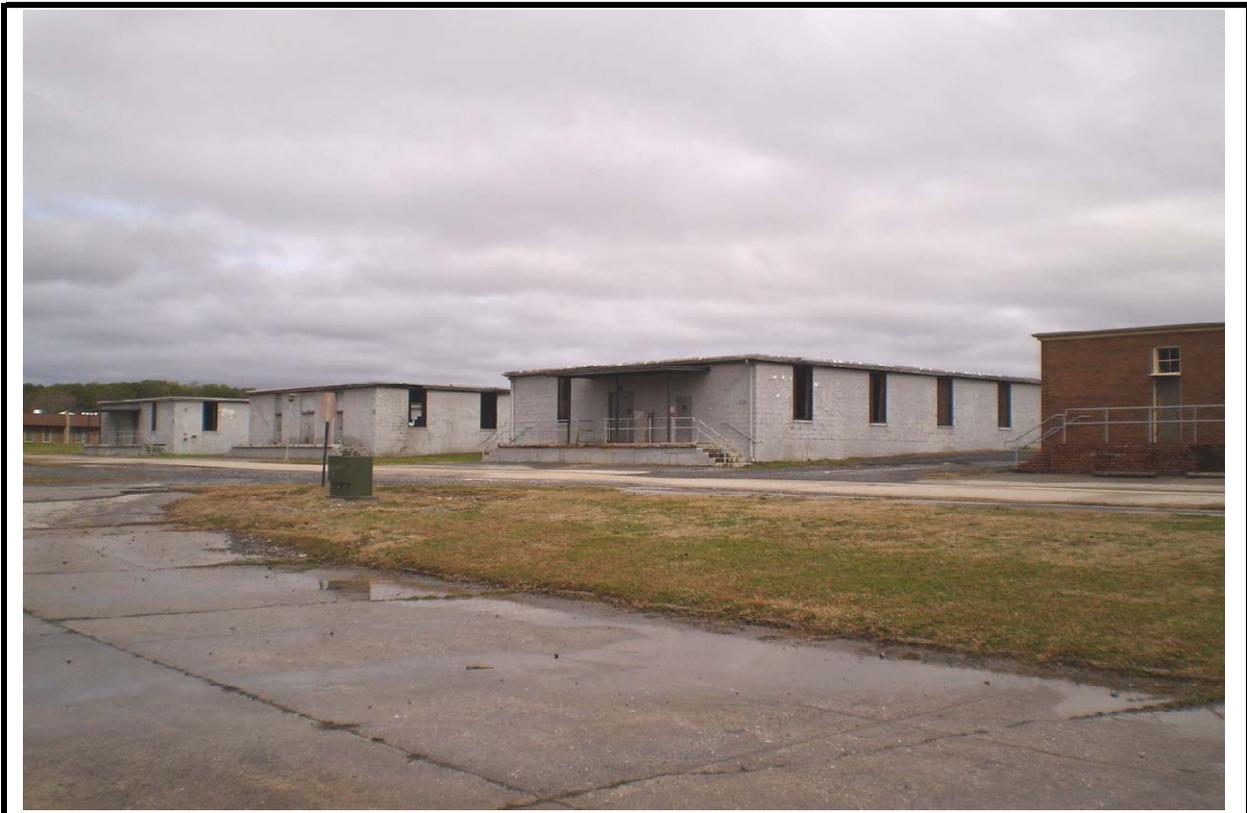
Photo 2

View of Buildings 809, 807, 805, and 803

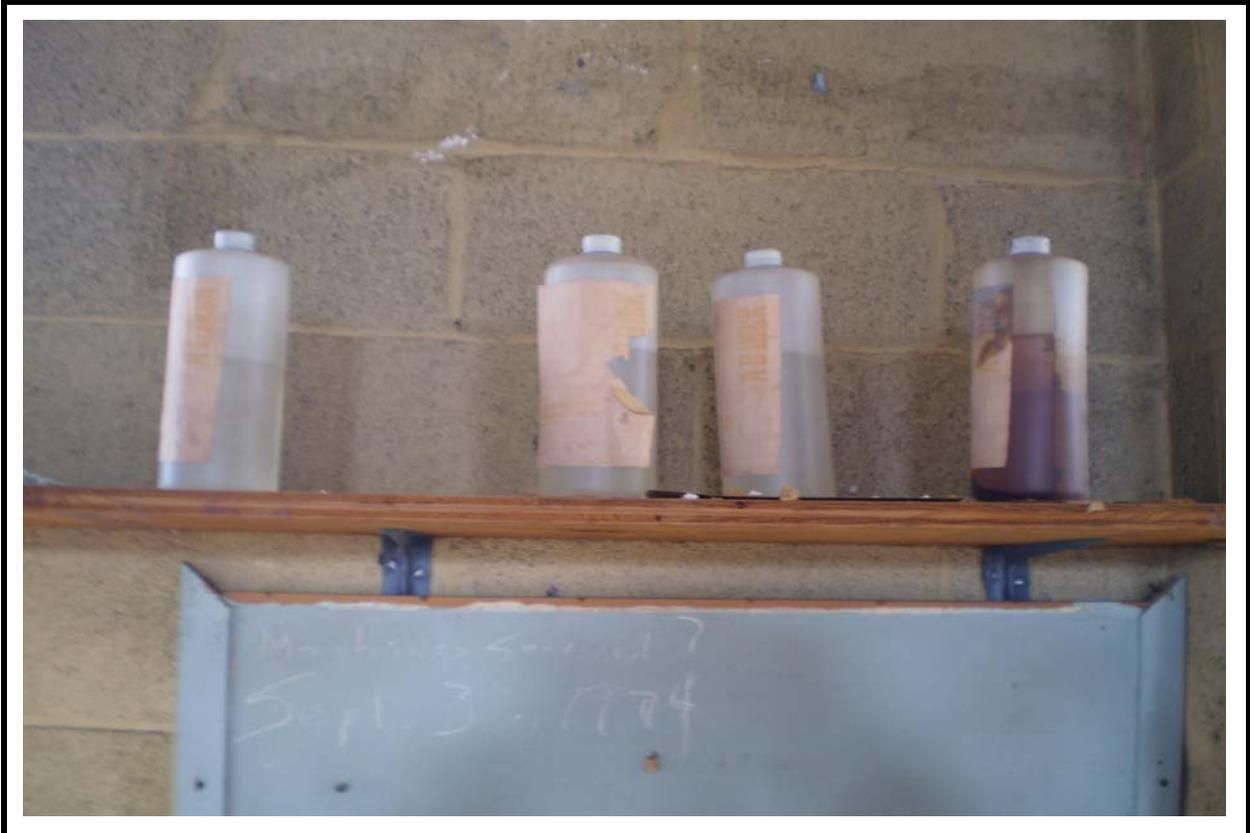
Photo 3 View of camera processing fluid (5, 1-quart containers) inside Building 805

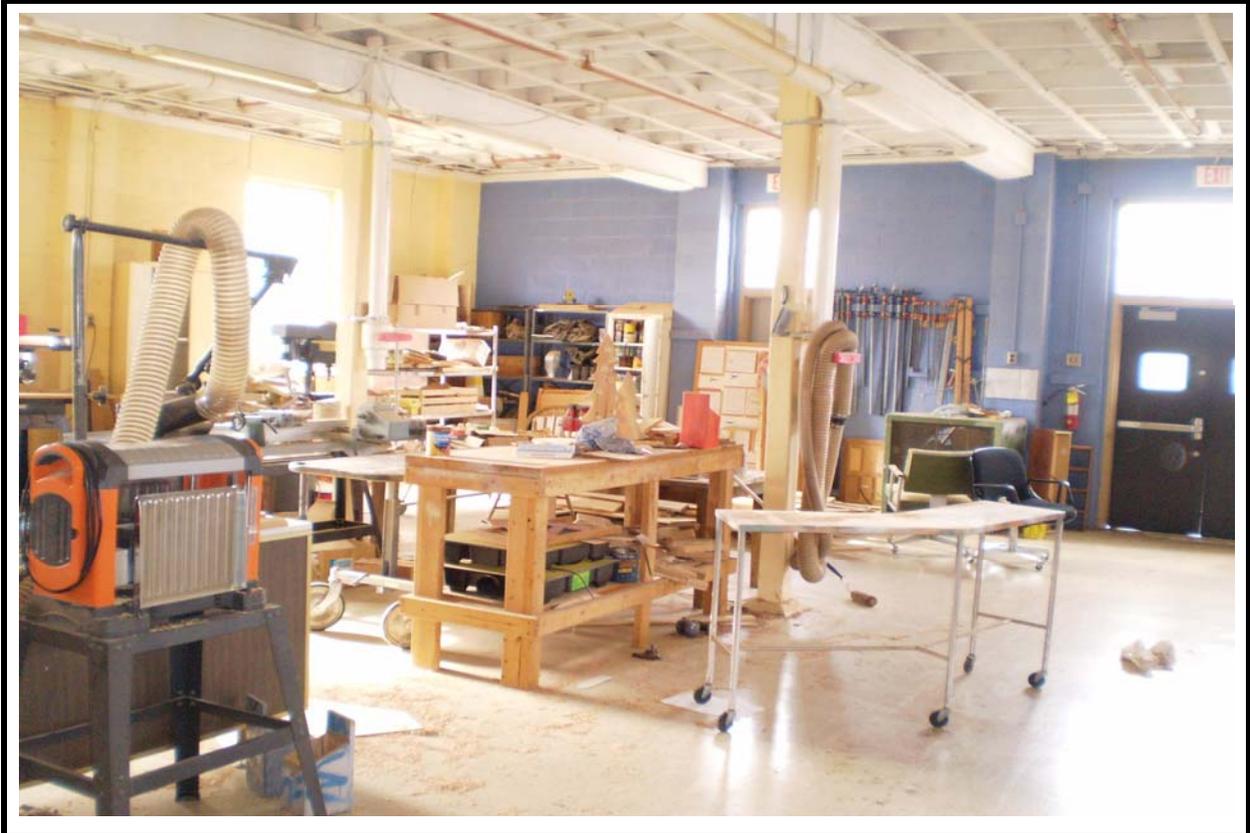
Photo 4 View of wood workshop inside Building 809

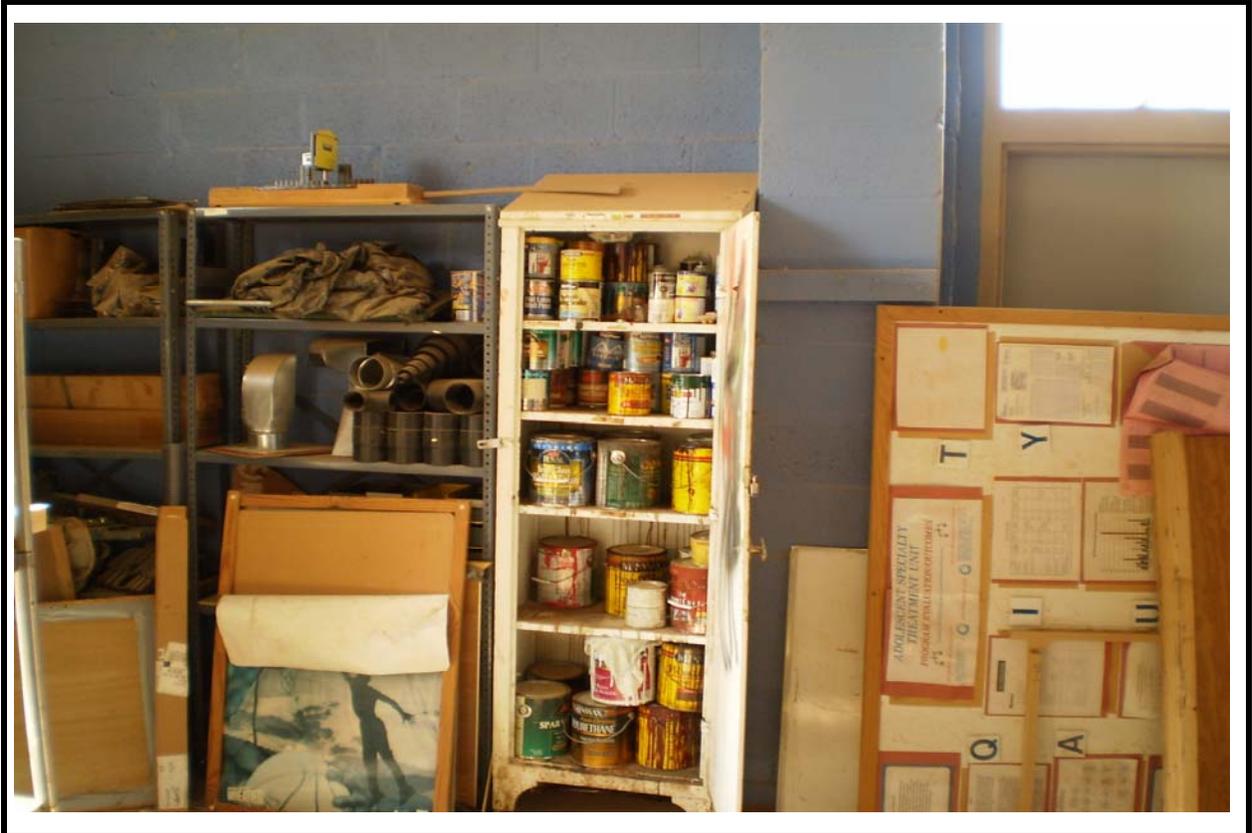
Photo 5 View of paint storage cabinet within Building 809 wood workshop

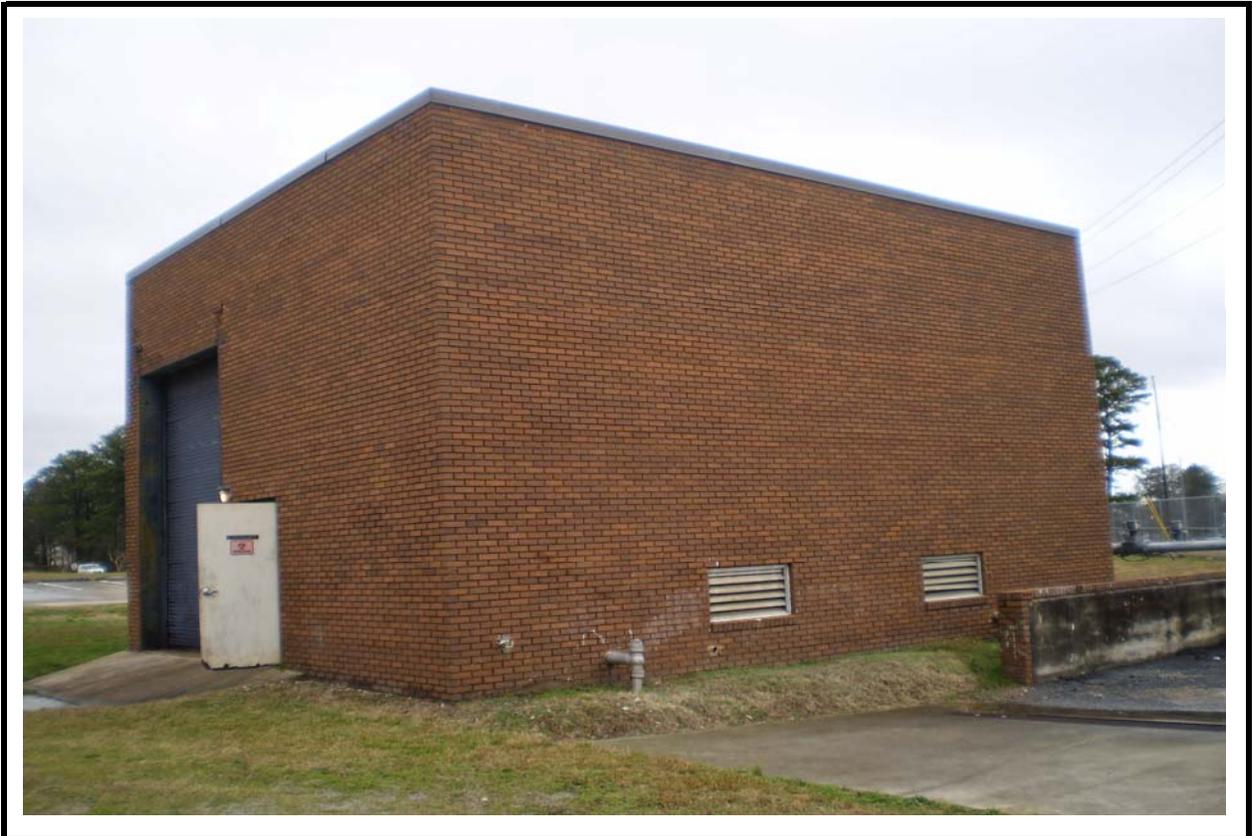
Photo 6 View of Bio-Hazard Storage (Building 903) and adjacent exterior trench drain

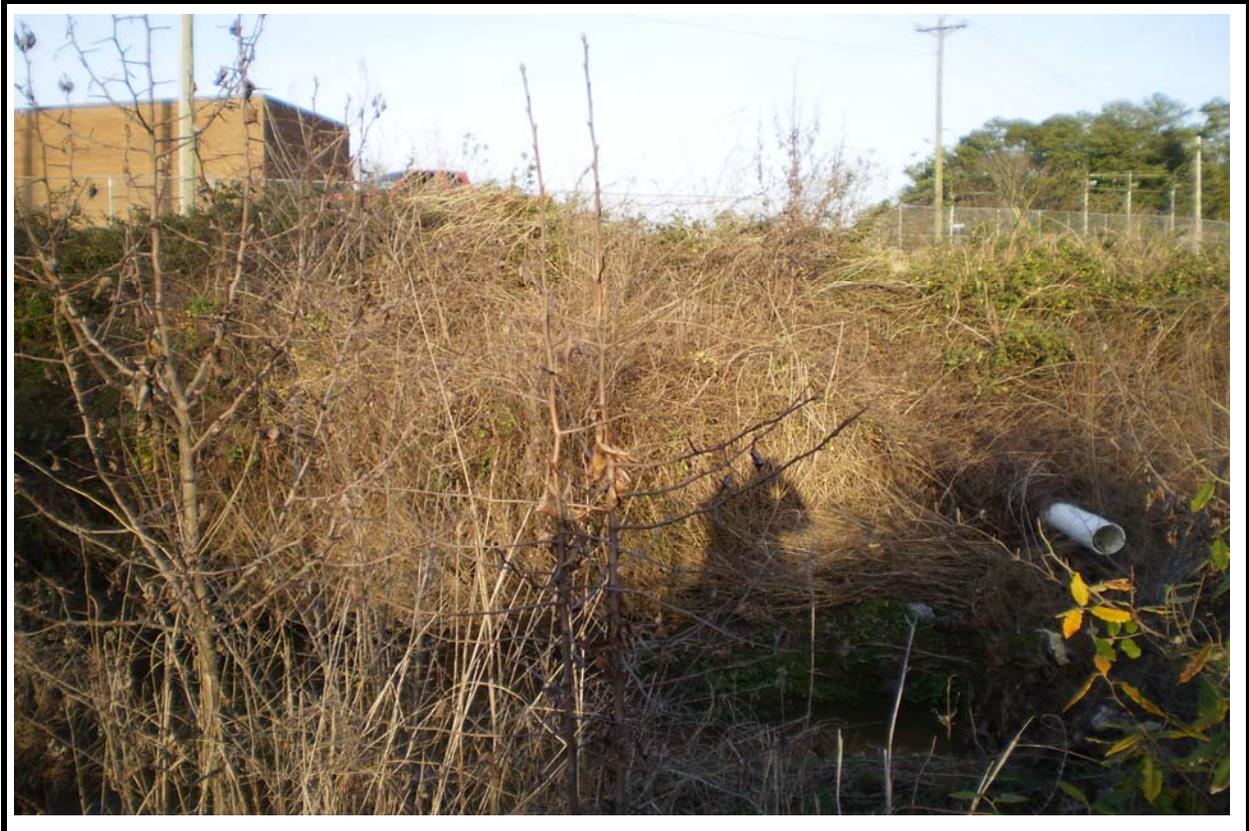
Photo 7 View of outfall from exterior drain observed adjacent to Bio-Hazard Storage (Building 903)

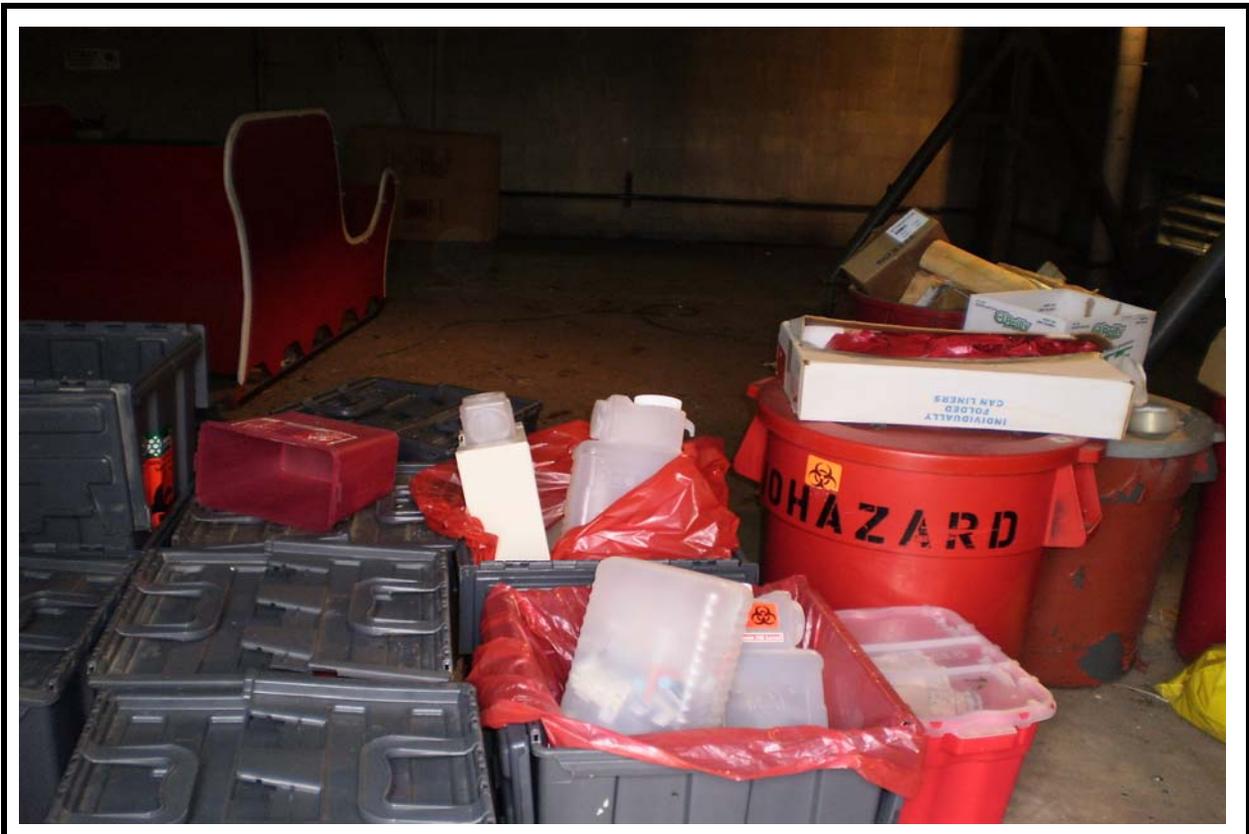
Photo 8 View of bio-hazard labeled material observed inside Building 903

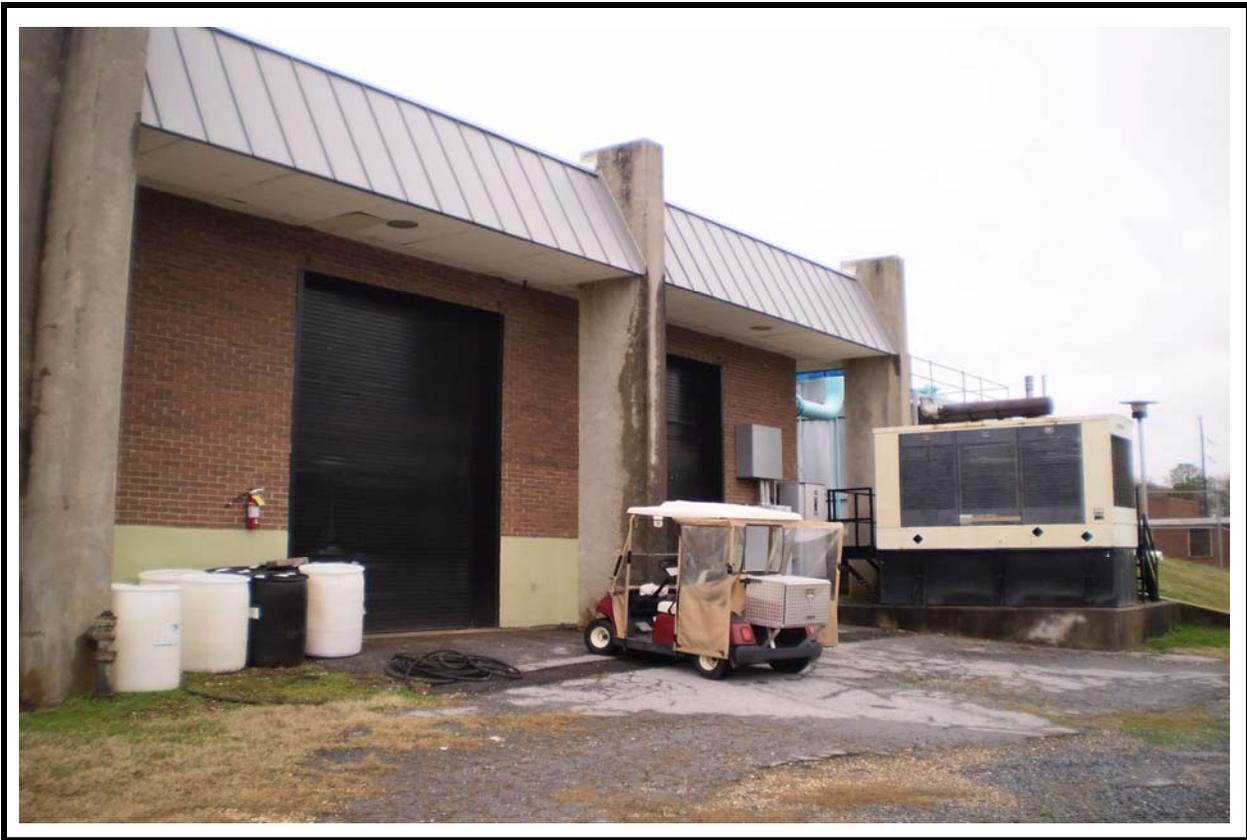
Photo 9 View of Building 911 (Chiller Plant), emergency generator, and empty 55-gallon drums of chiller mixing reagents.

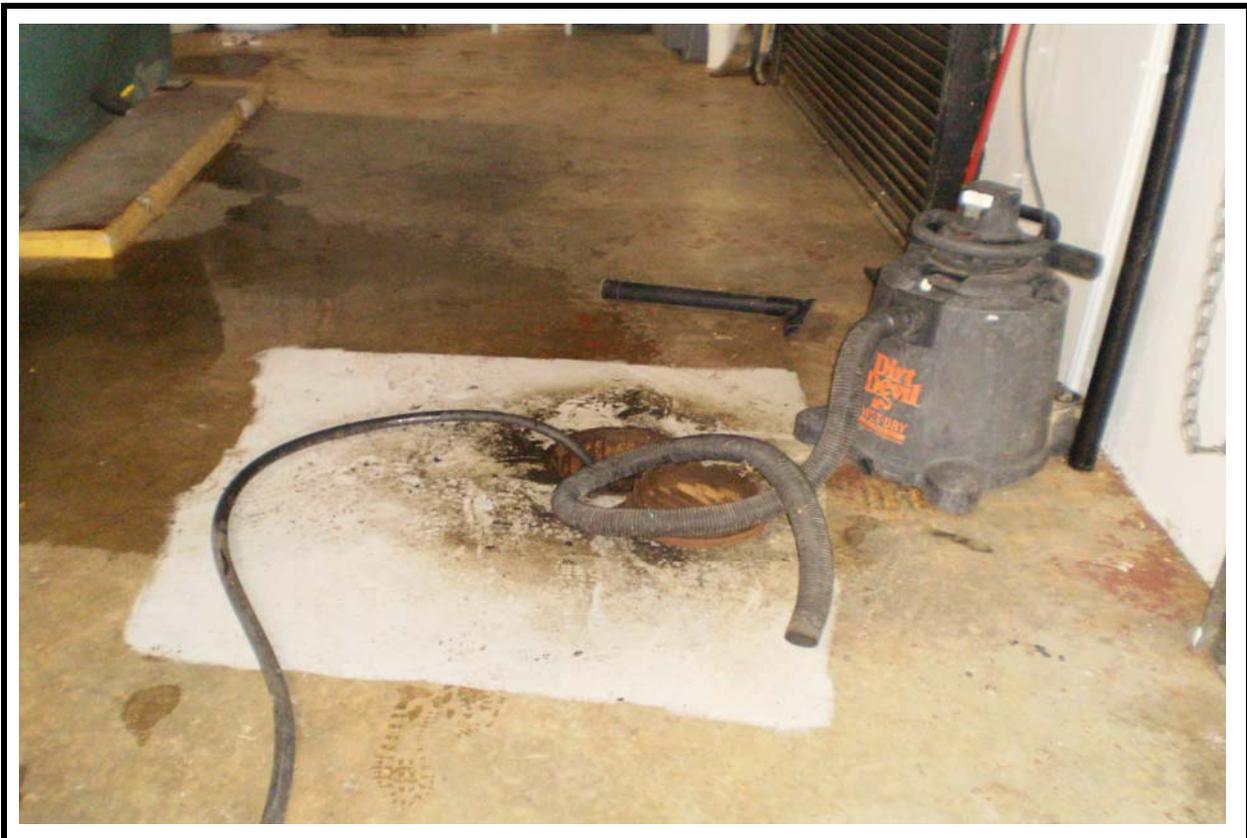
Photo 10 View of interior floor drain within Chiller Plant

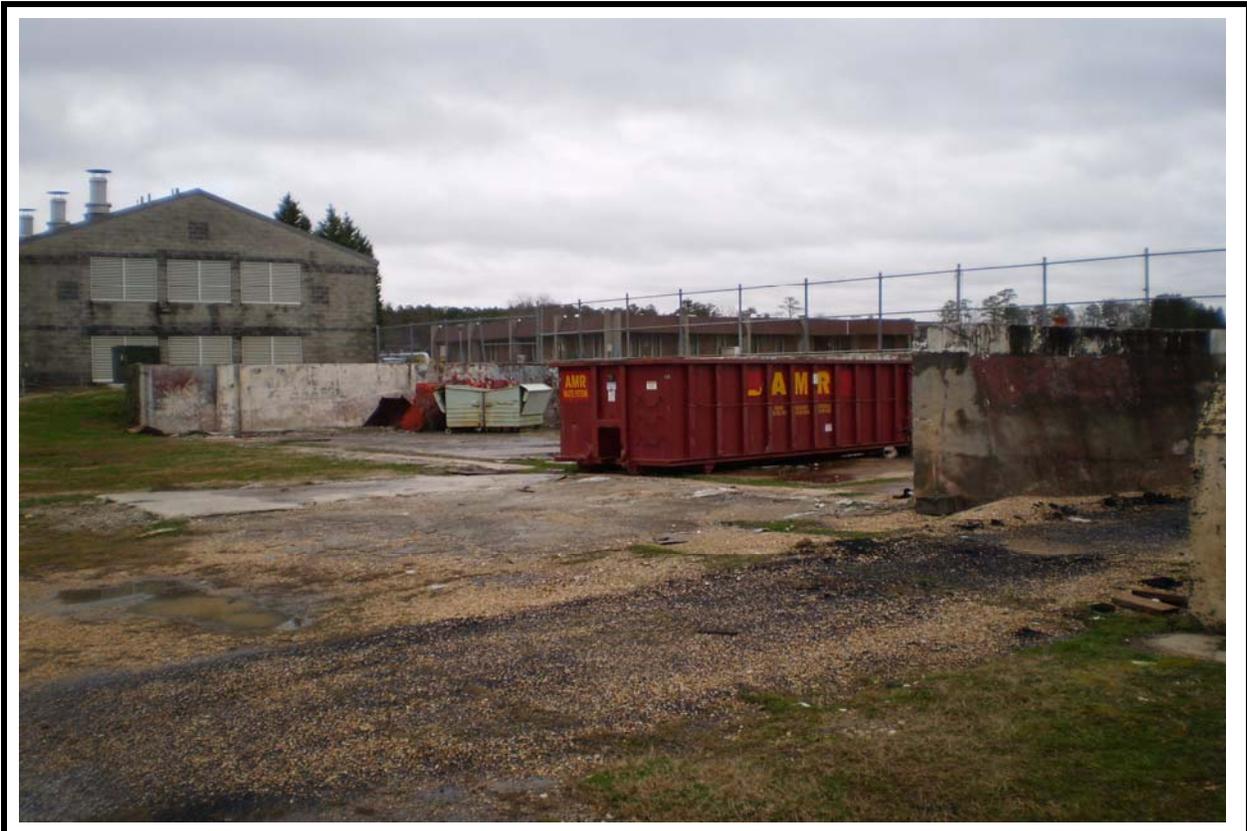
Photo 11 View of location of former location of Steam Plant (current roll-off recycling area) with Active Steam Plan (Building 902) in background

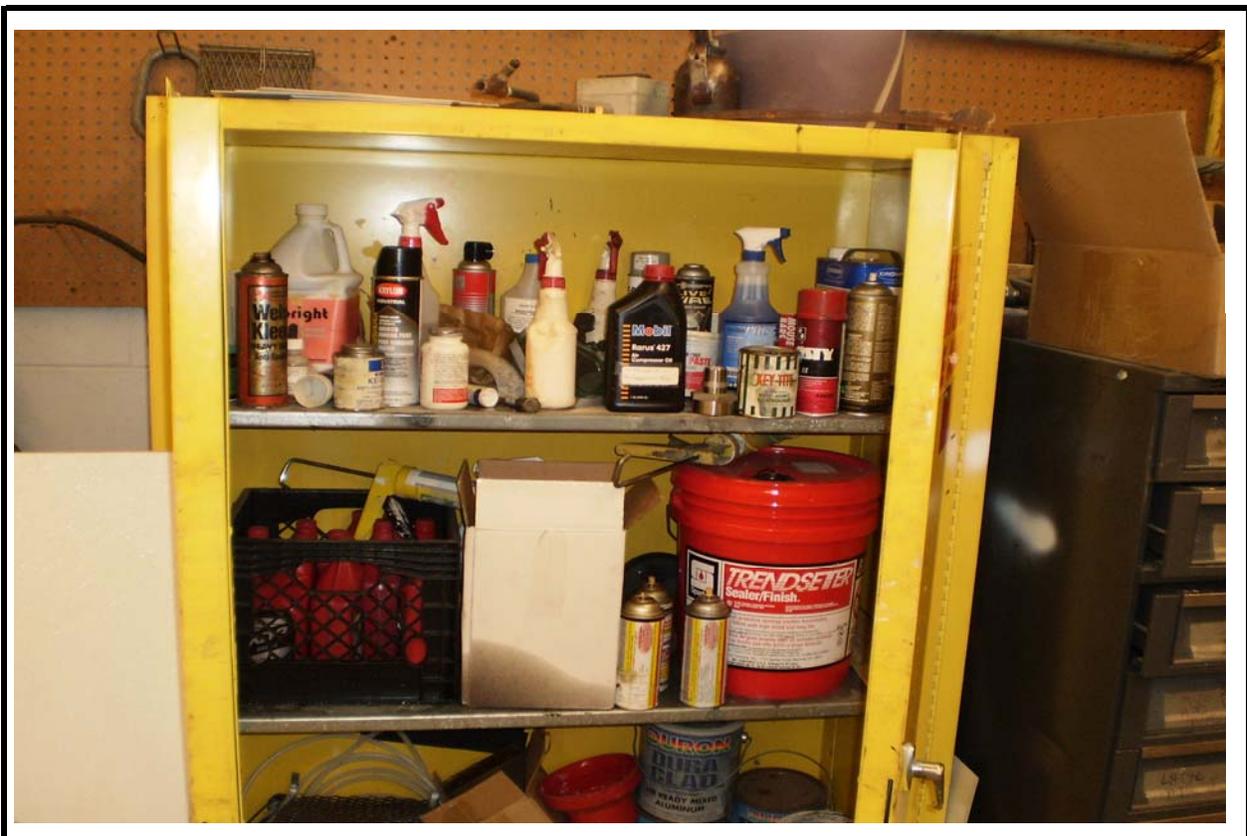
Photo 12 View of flammable liquids storage cabinet observed inside the Steam Plant maintenance area

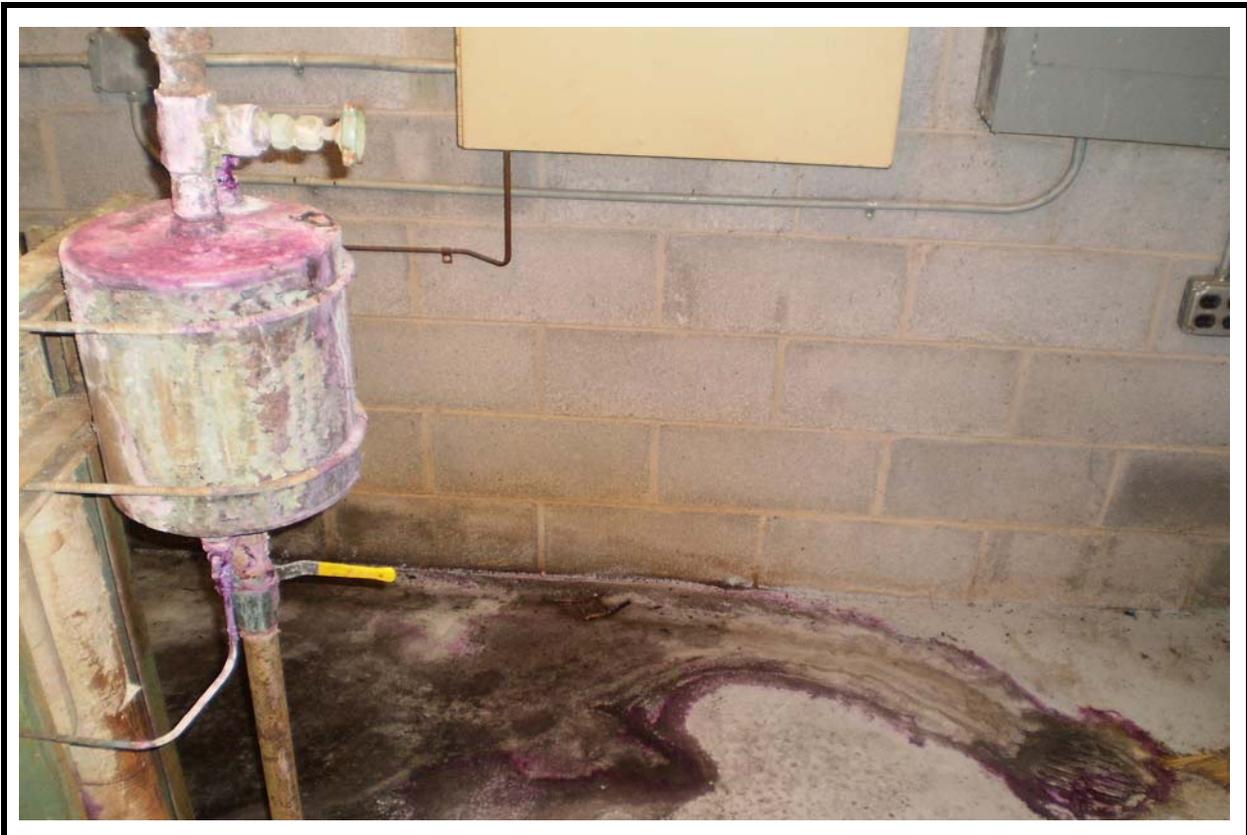
Photo 13 *View of Building 300 water transfer room and interior floor drain staining*

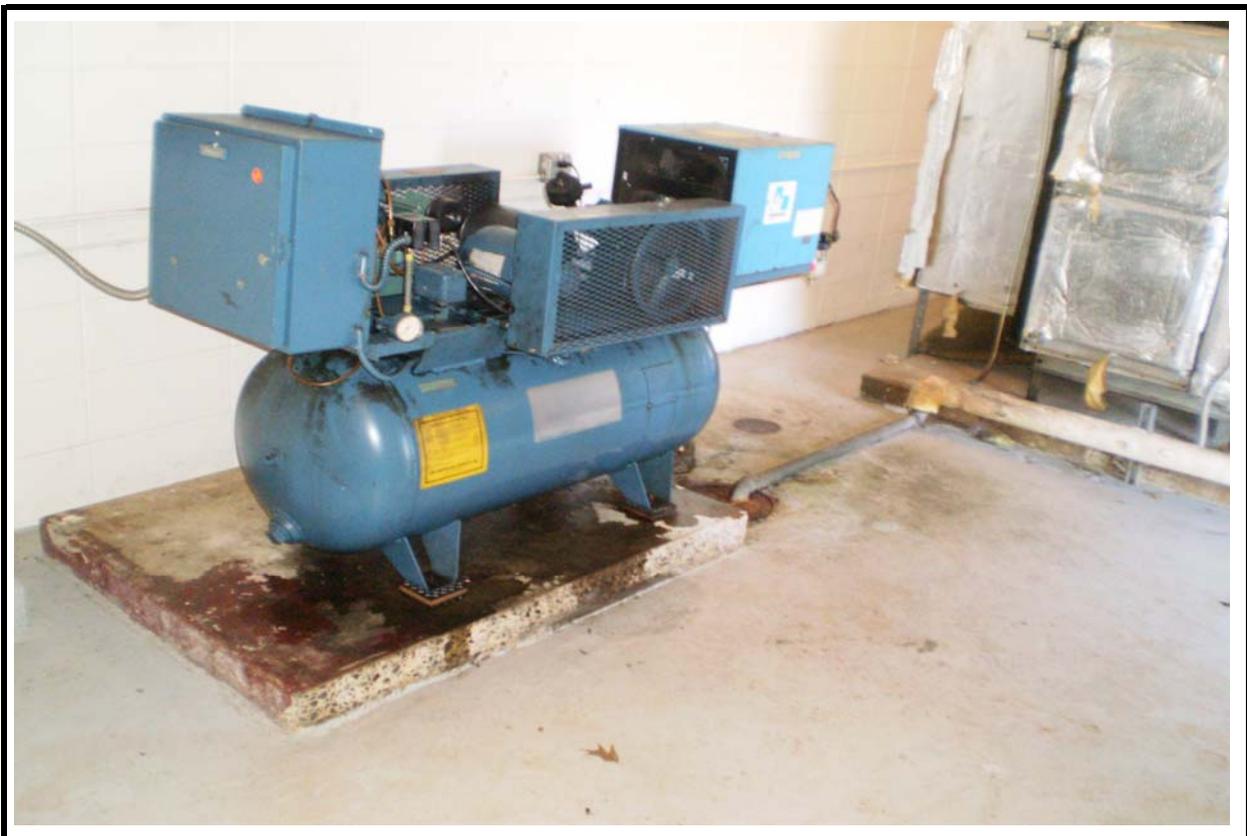
Photo 14 *View of air compressor and oil staining observed inside Building 300 mechanical room*

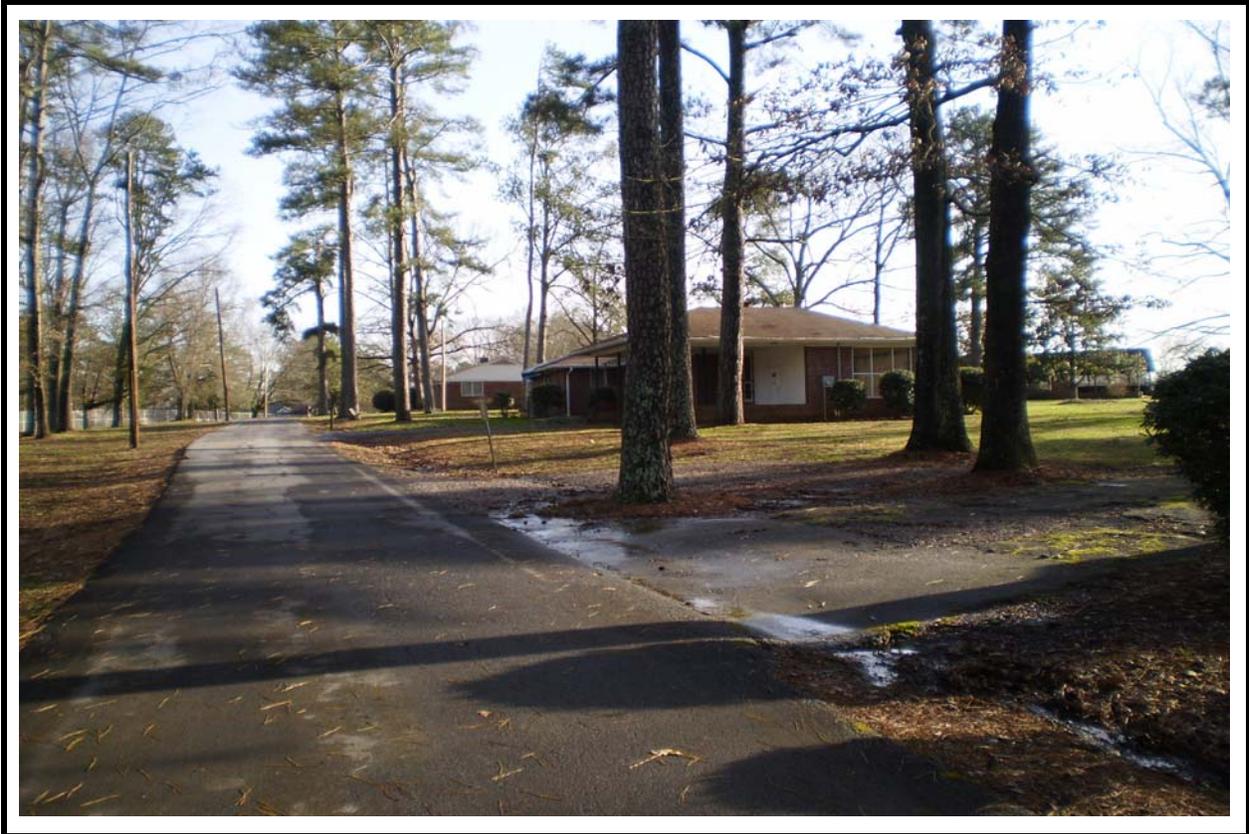
Photo 15

View of 1100 Housing Area along Battey Circle

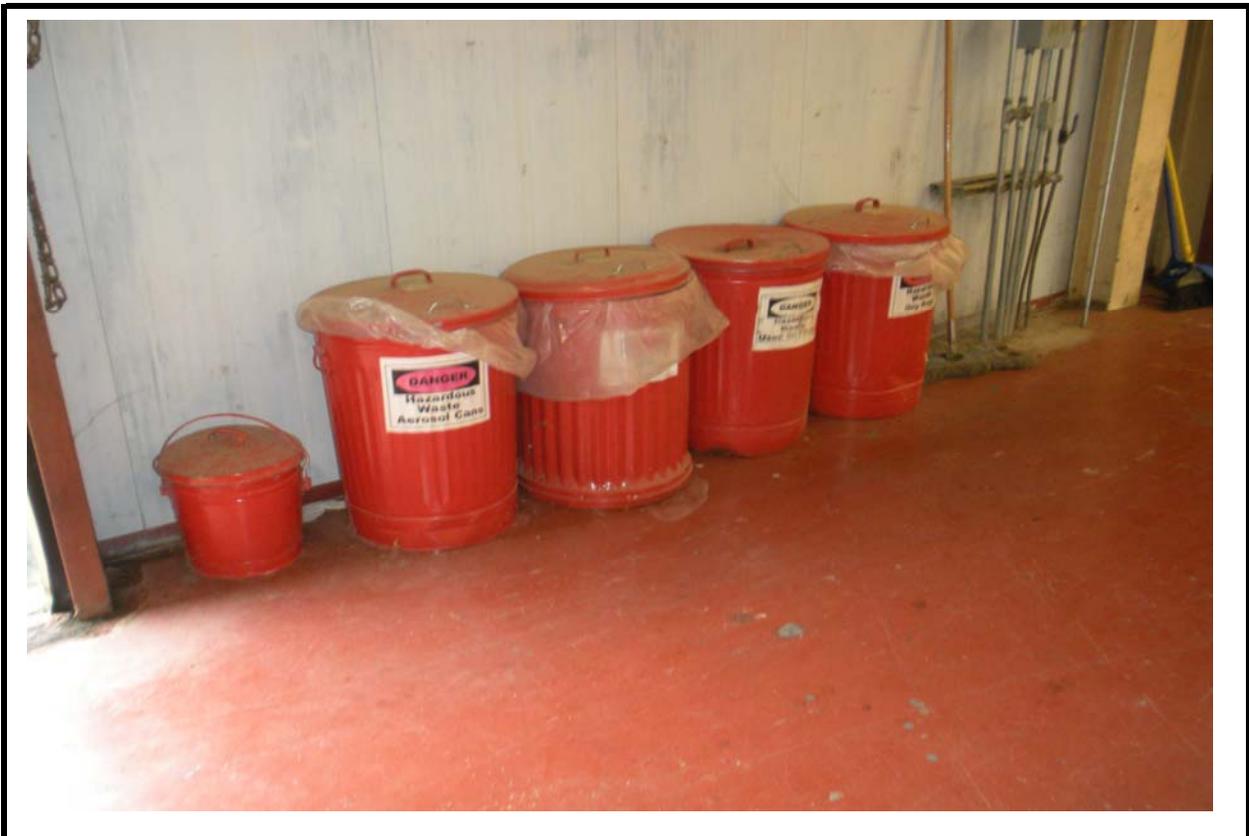
Photo 16

Waste disposal and recycling within the shop areas of the 920 Building

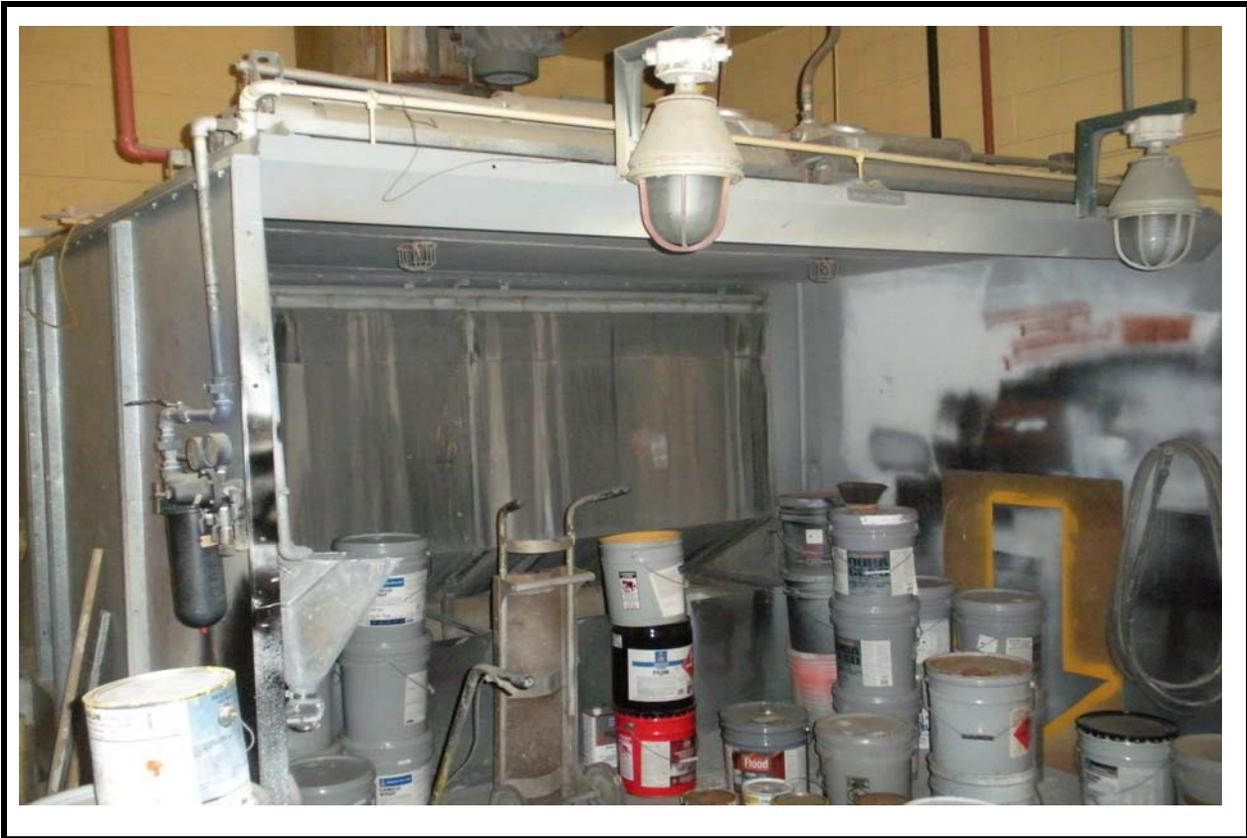
Photo 17

Former paint booth located inside the workshop areas of the 920 Building

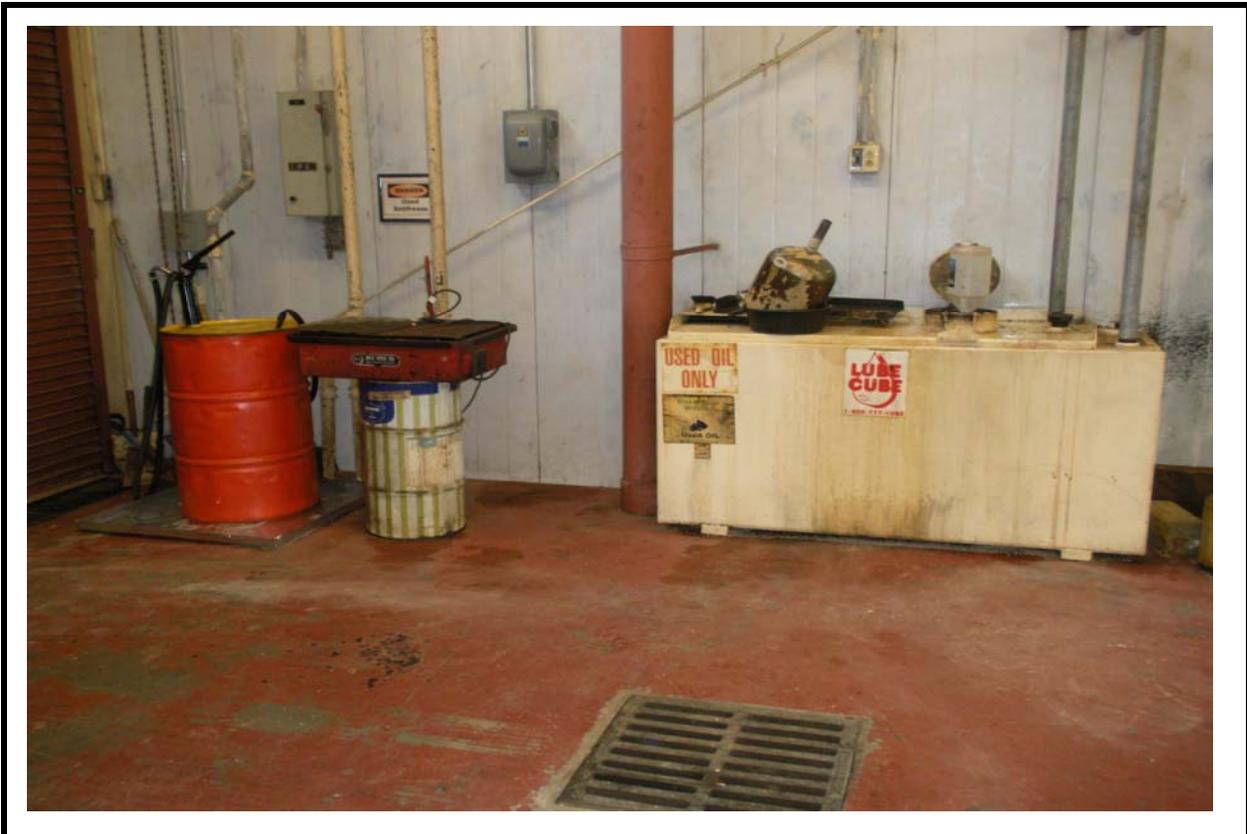
Photo 18

Waste oil AST, parts washer and 55-gallon drum of motor oil located inside the vehicle maintenance bay of the 920 Building

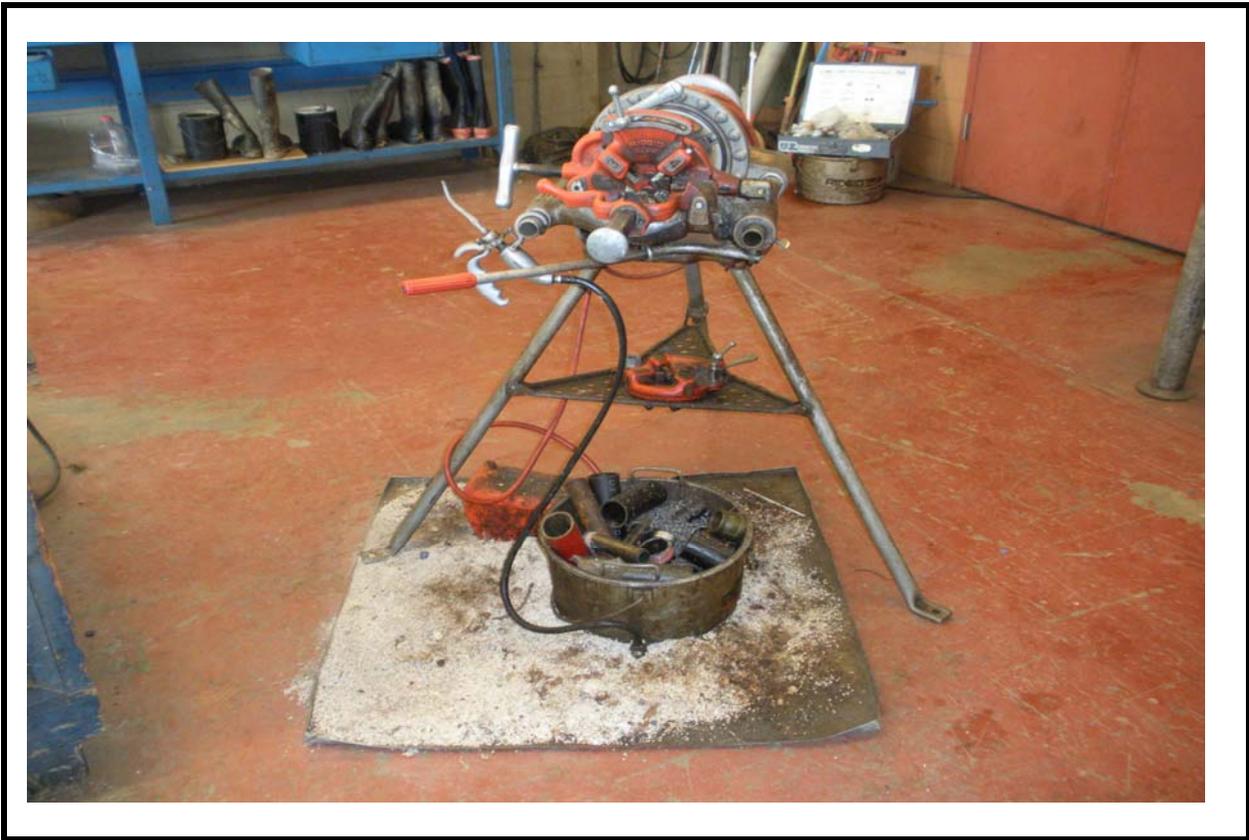
Photo 19 Parts repair shop inside the 920 Building; note absorbent material to contain spilled petroleum product

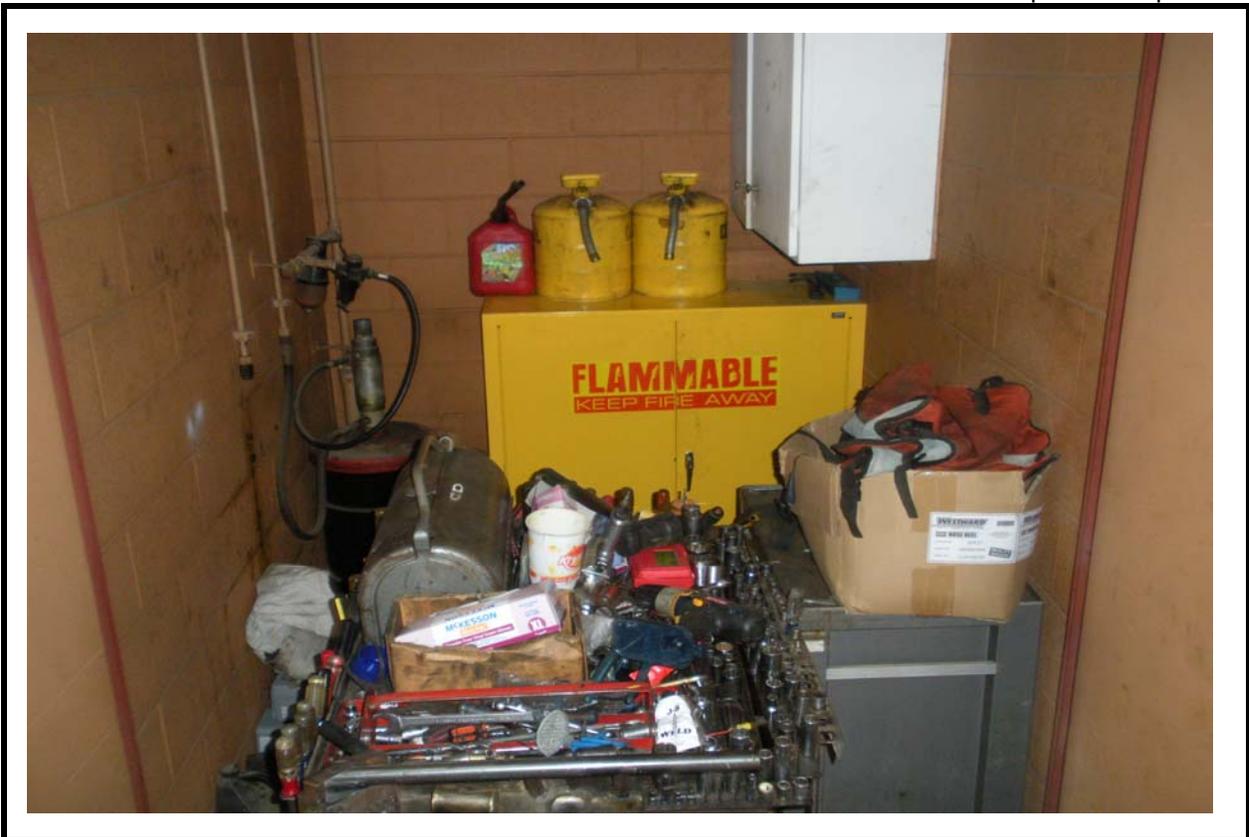
Photo 20 Storage closet inside the maintenance bays of Building 920; note small drum and piping on wall. The piping was previously utilized as part of the pumping system for motor oil and lubricants during vehicle maintenance

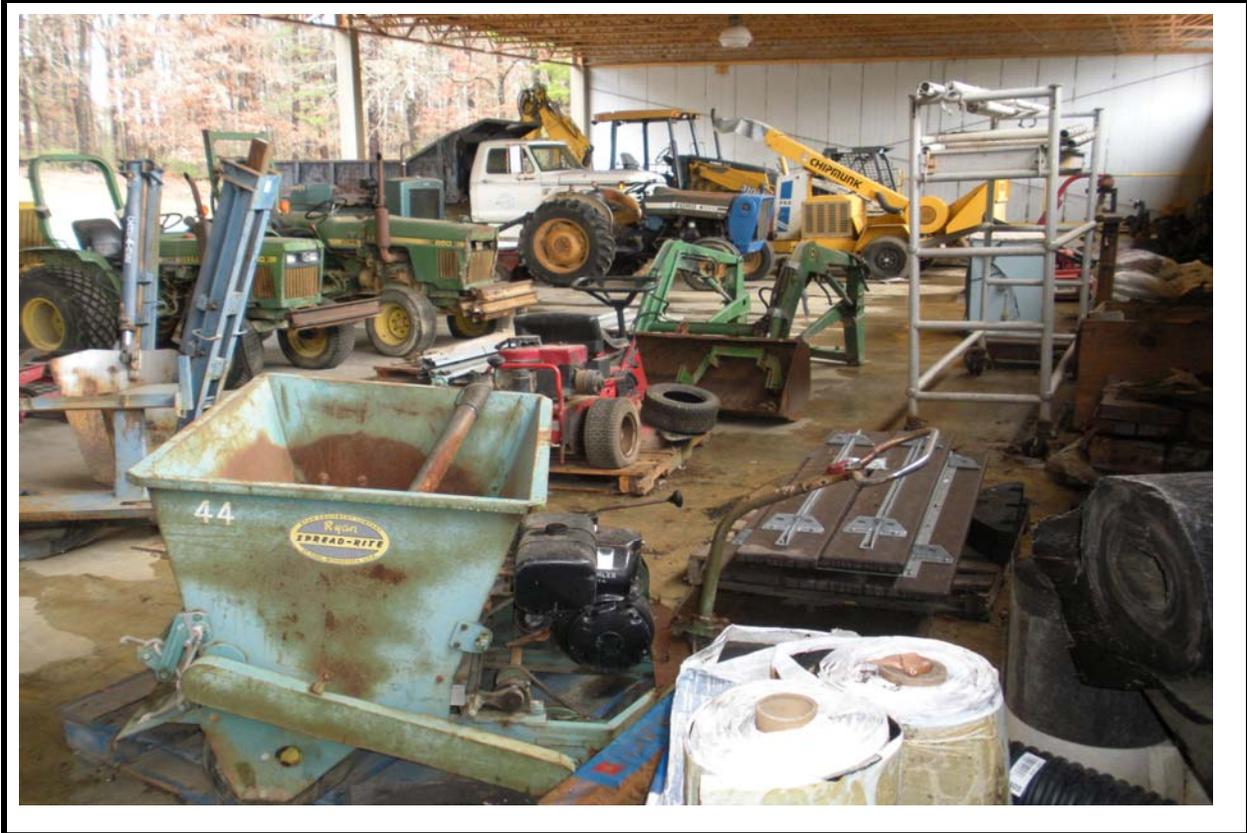
Photo 21 View of large shed which houses equipment utilized for property landscaping and maintenance
