PHOTOGRAPHS

PHOTOGRAPH LOG

SITE: Former Northwest Regional Hospital Property

DATE: January 23-24, 2012

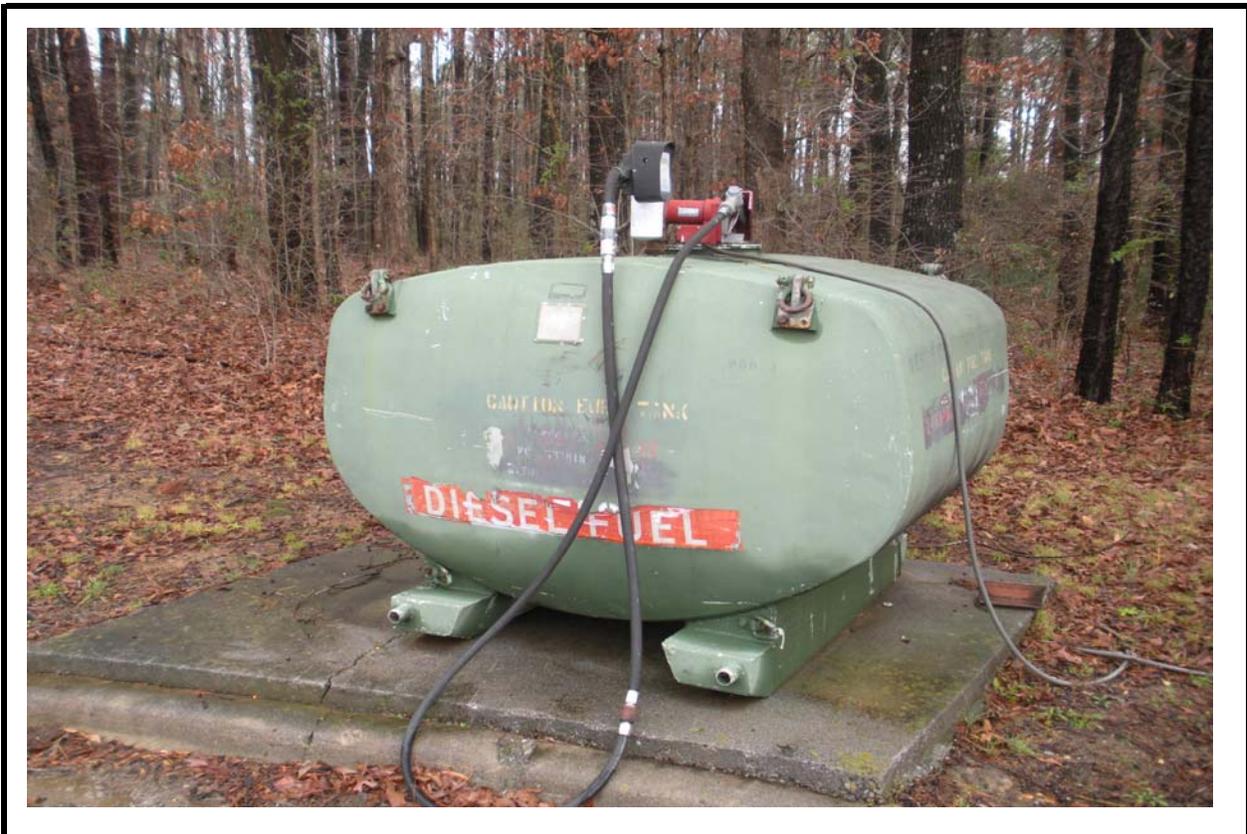
Photo 22 600 gallon diesel AST located northeast of the 920 Building and adjacent to the aforementioned shed which houses property equipment

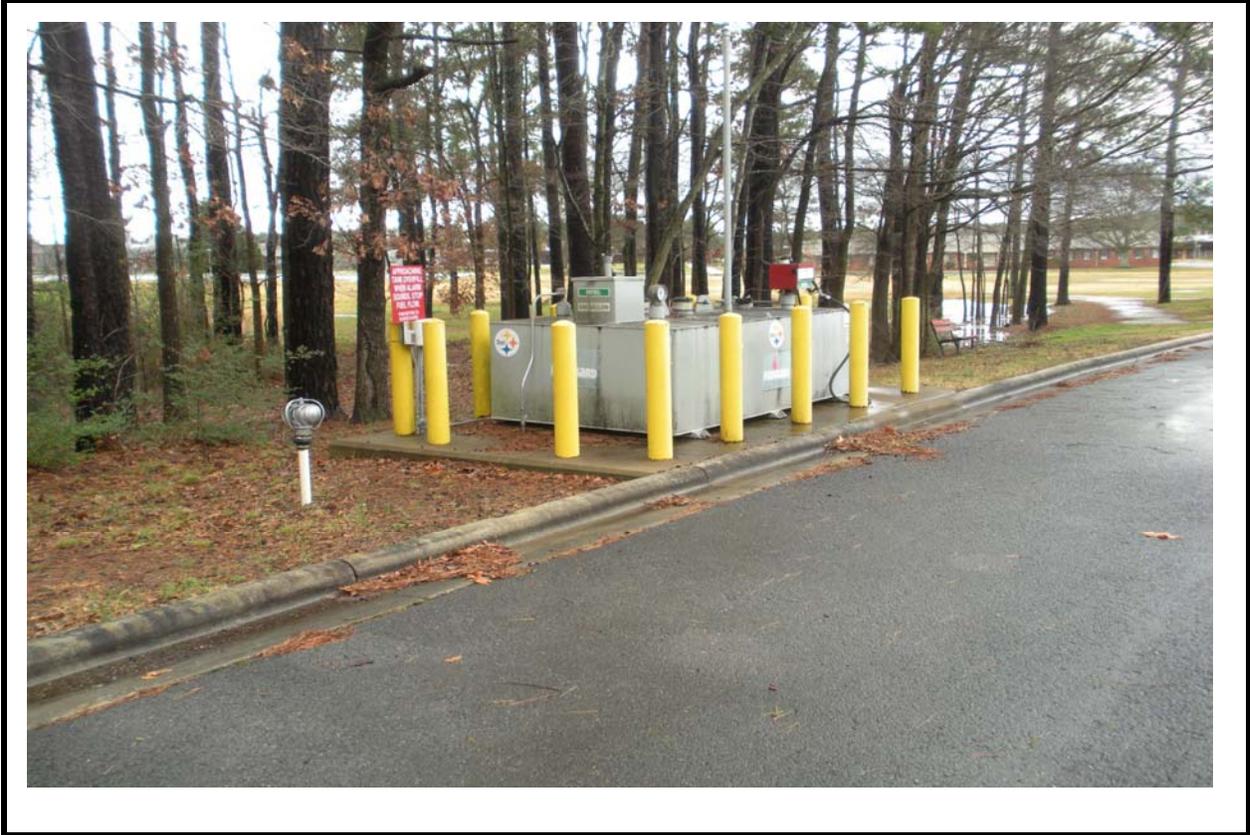
Photo 23 An additional diesel AST (650 gallons) located approximately 30 yards south of the aforementioned 600 gallon diesel AST

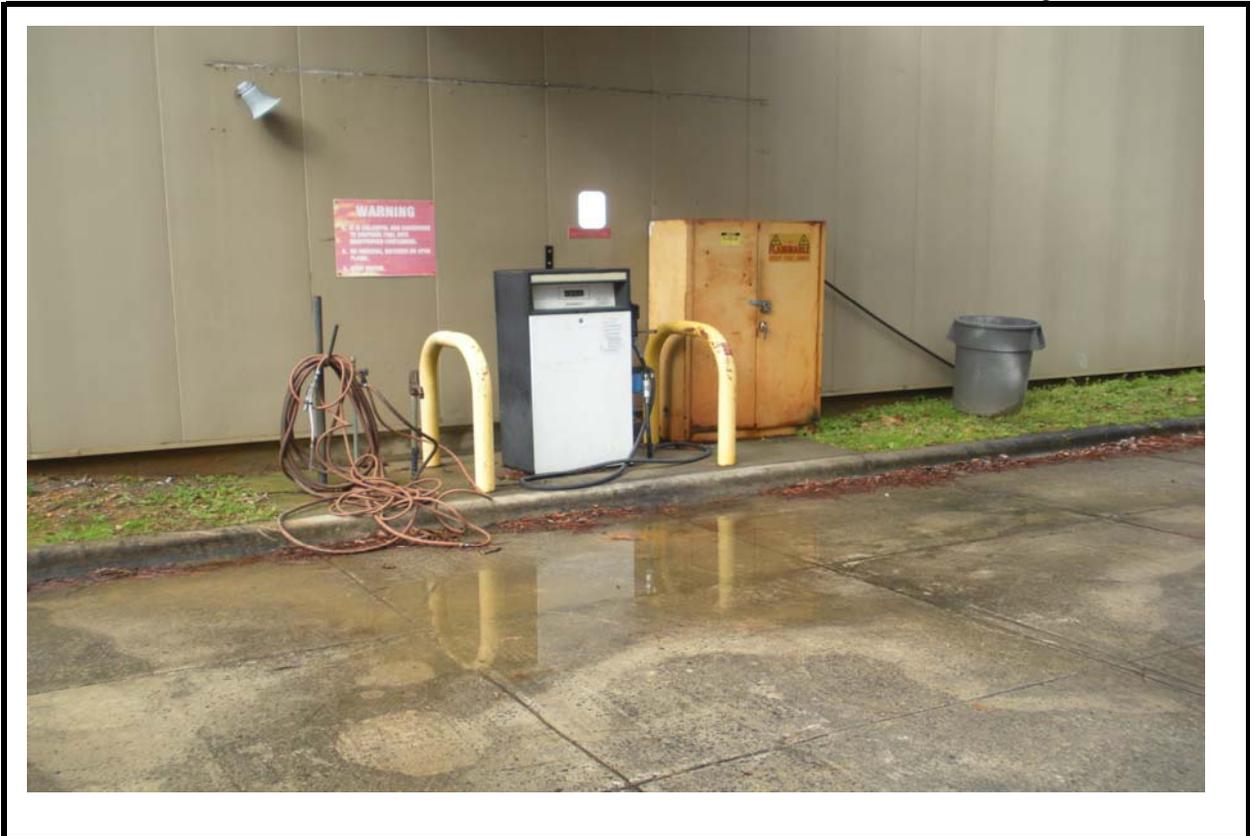
Photo 24 Fueling dispenser associated with the 2,500 gallon gasoline UST near the southeastern corner of the large equipment shed

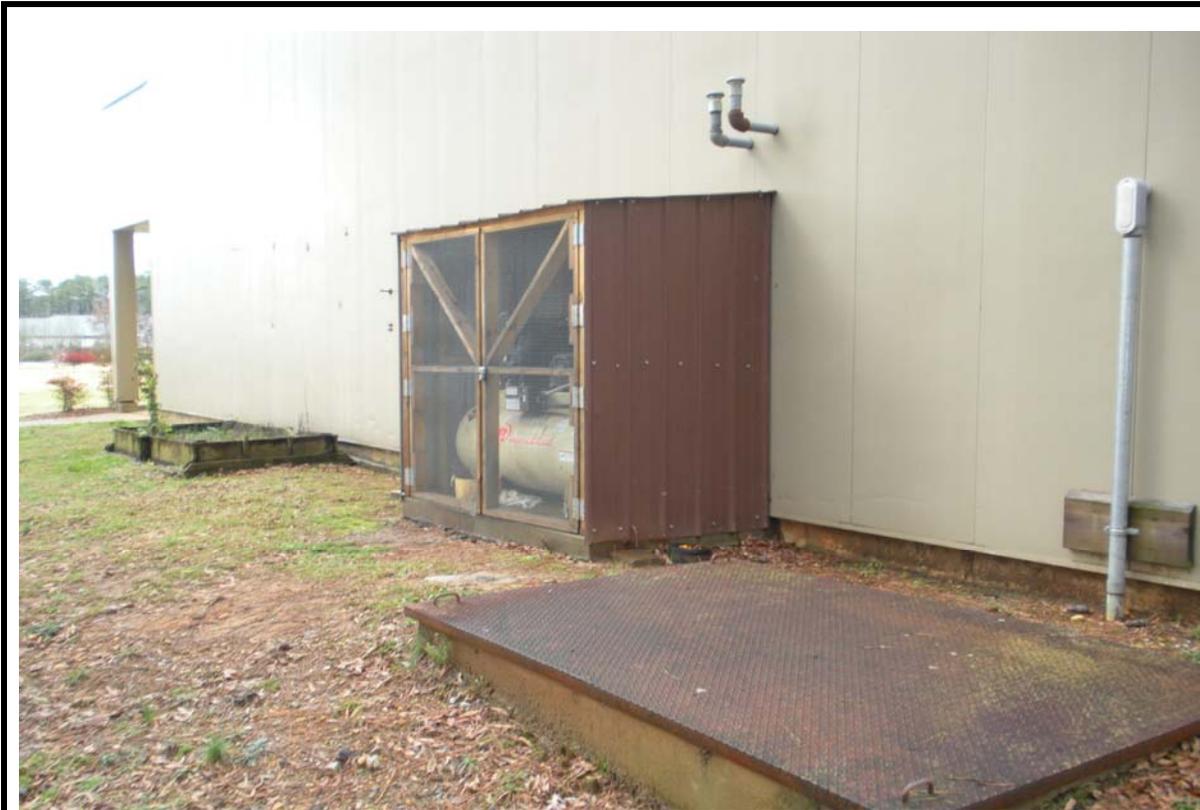
Photo 25 View of the area adjacent to the maintenance bay at the eastern end of the 920 Building; Notable items are the vent lines for the aforementioned waste oil AST and the pit which contains a sand filter box tied into the sanitary sewer drain system for Building 920

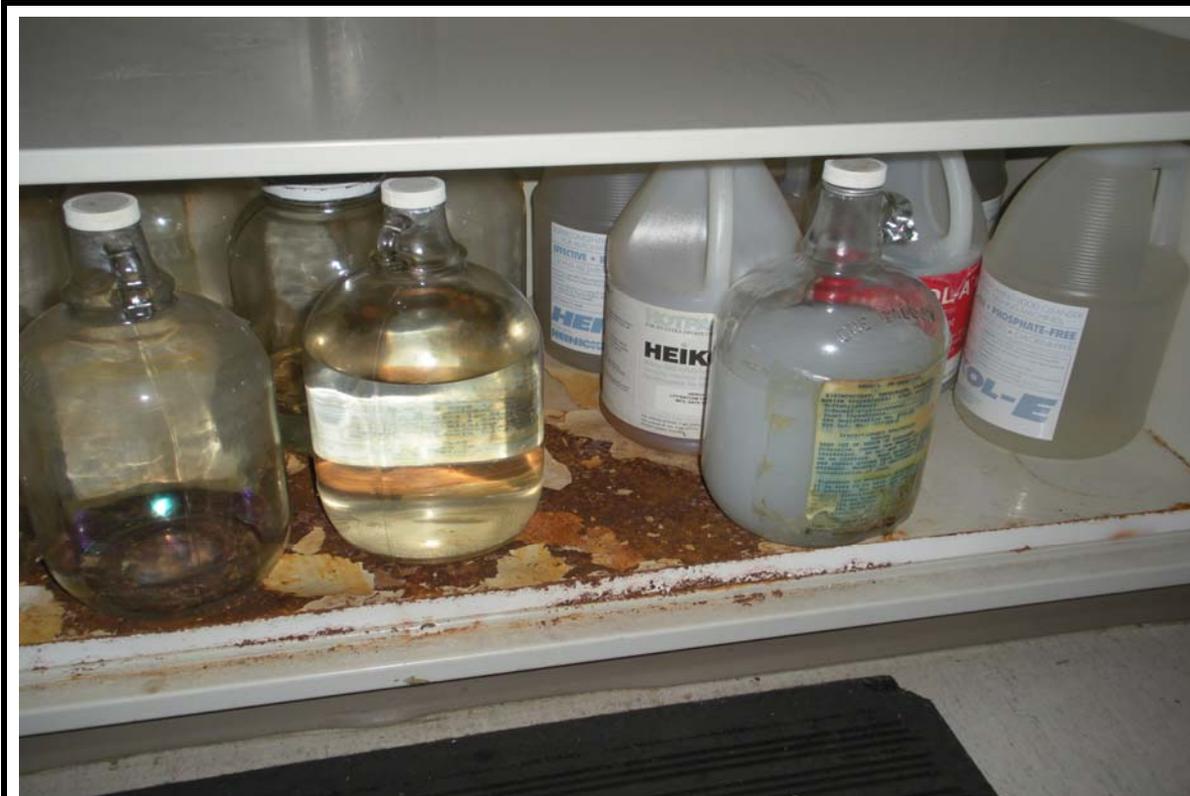
Photo 26 Chemicals observed inside the former lab areas of Building 304

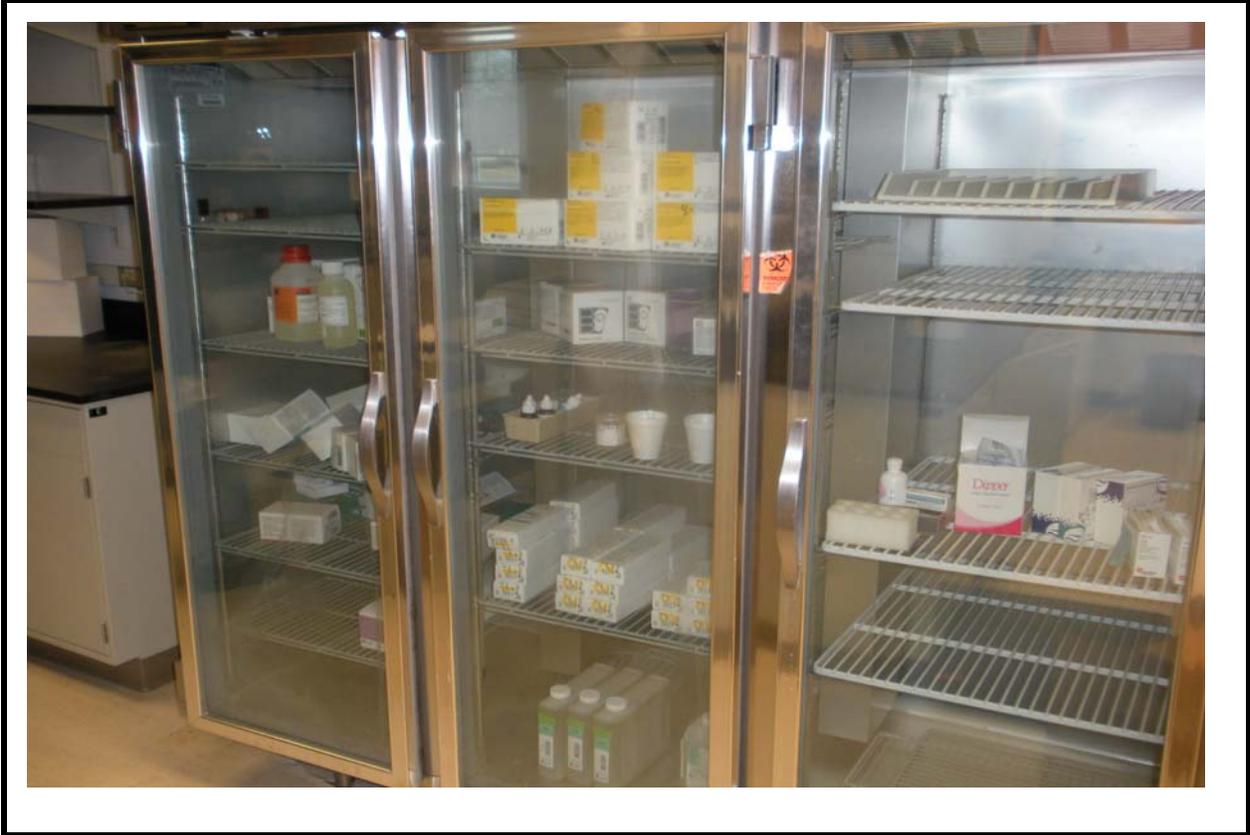
Photo 27 Additional chemicals and some biohazards observed in the former lab areas of Building 304

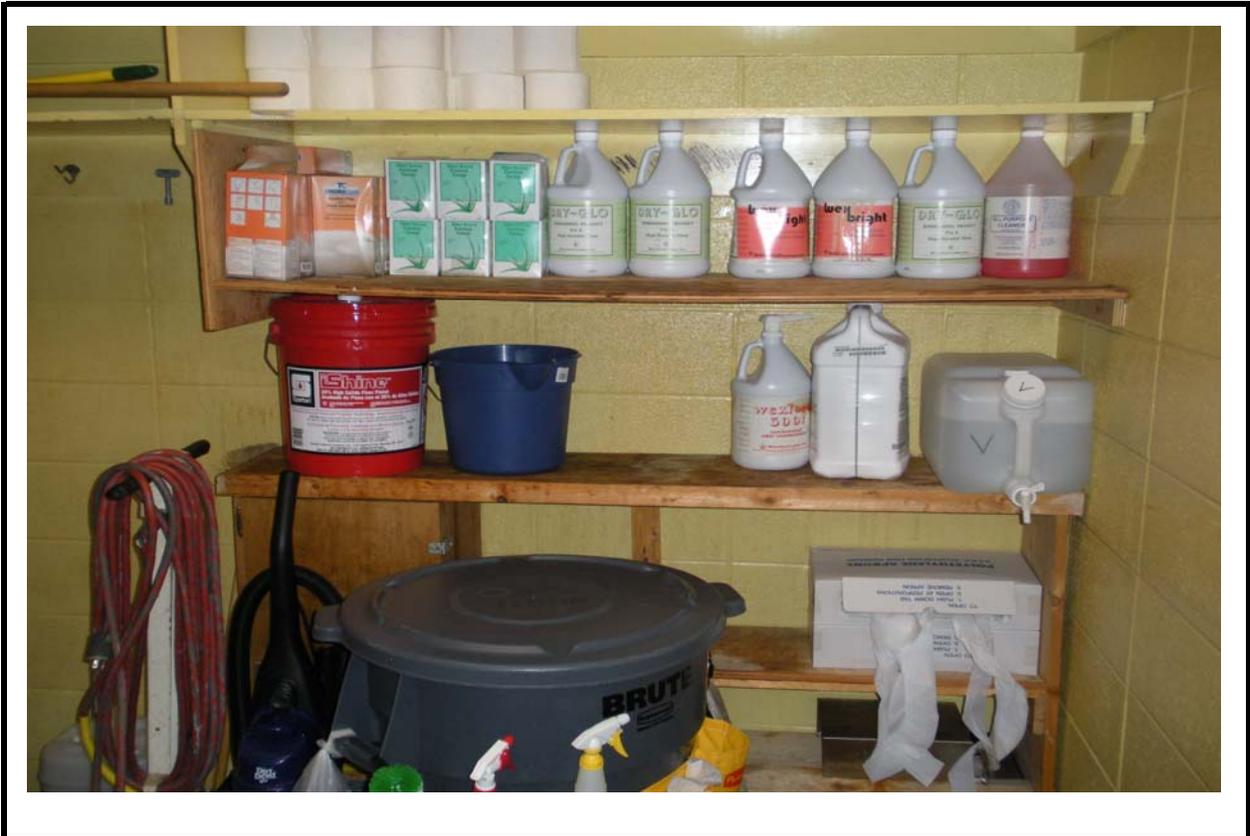
Photo 28 Cleaning agents associated with building maintenance stored inside a custodial closet of the lab building
