STRUCTURAL OBSERVATION REPORT

PROJECT NAME: ROME CLOCK TOWER
ADDRESS: ROME, GA

WEC JOB NO.: 216157

PREPARED FOR: MS. JOHNNA ALLEN
DATE: JUNE 1, 2016

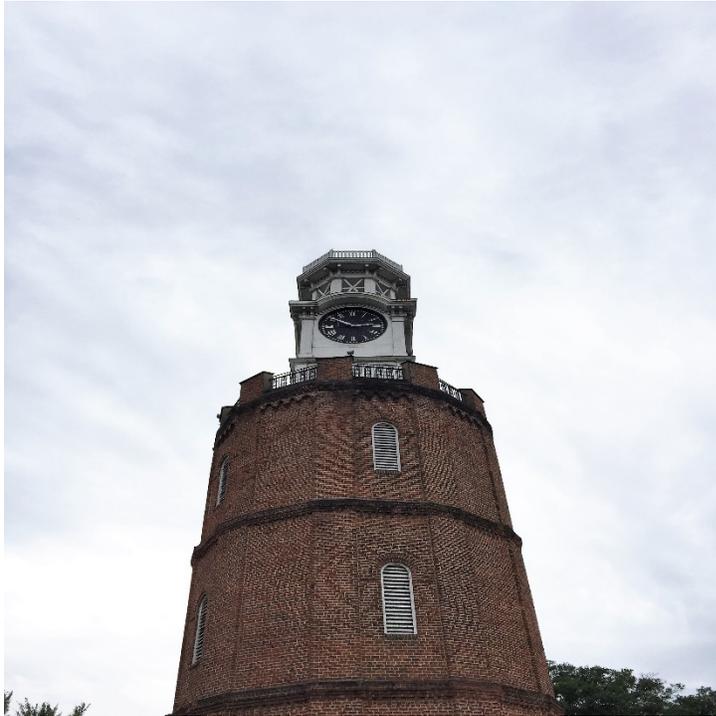
PHOTO #:1

View of clock tower

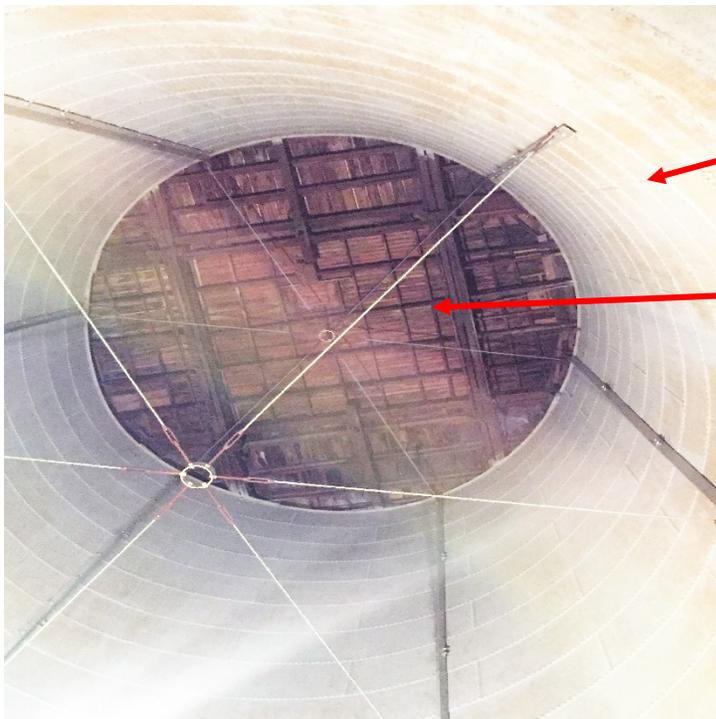
PHOTO #:2

Wall of steel water tank

Upward view of underside of lowest level of the clock tower wood framing

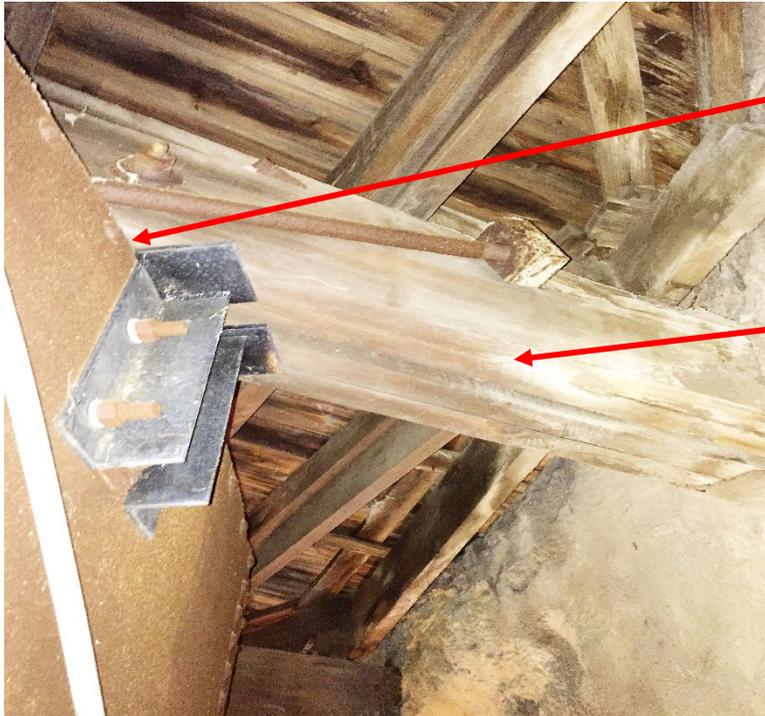
PHOTO #3

Outside wall
of steel water
tank

Wood
framing at
underside of
lowest level
of the clock
tower framing

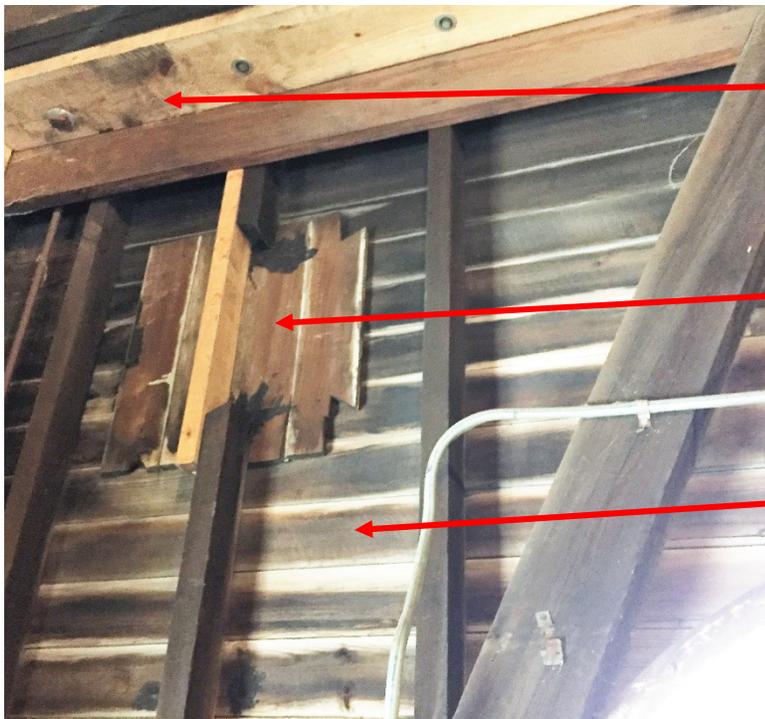
PHOTO #4

Previous
repair work

Exterior wall

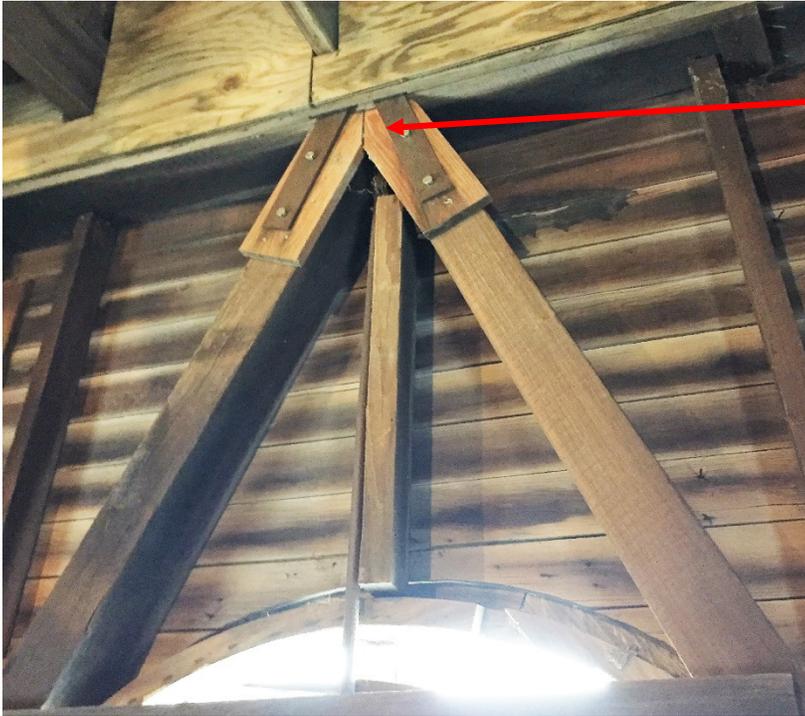
PHOTO #:5

Previous reinforcement/repair at bracing

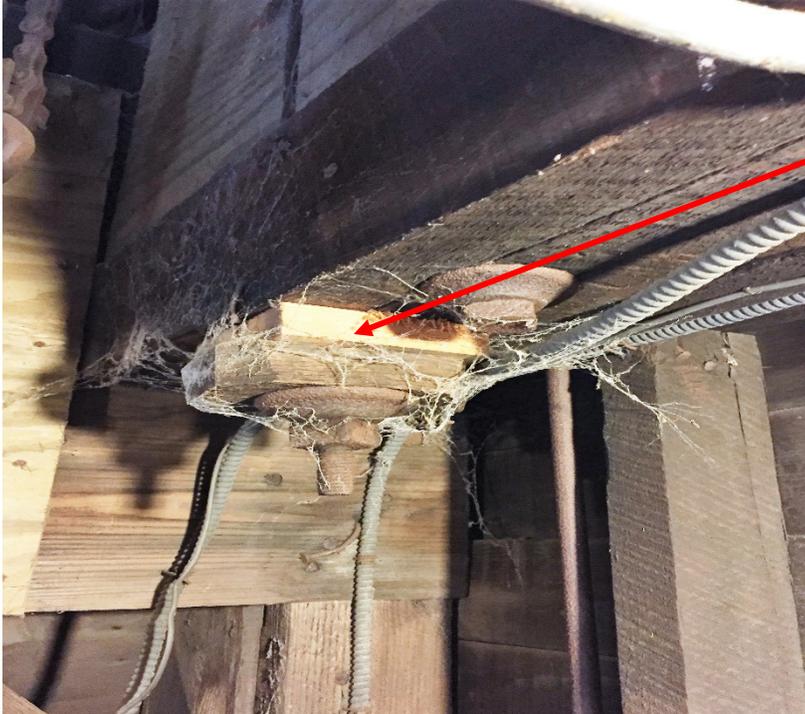
PHOTO #:6

Previous repair work (wooden shims at rod)

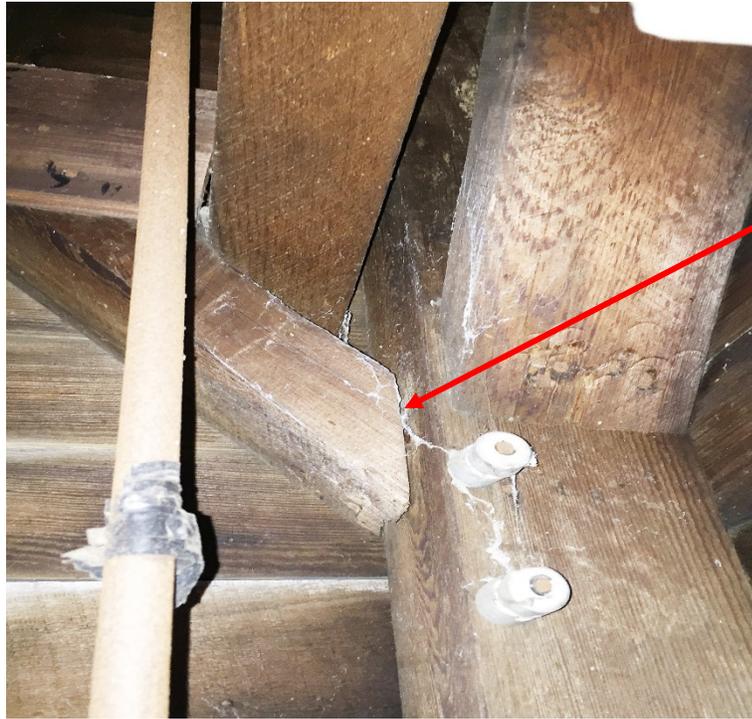
PHOTO #:7

Gap between
brace &
column

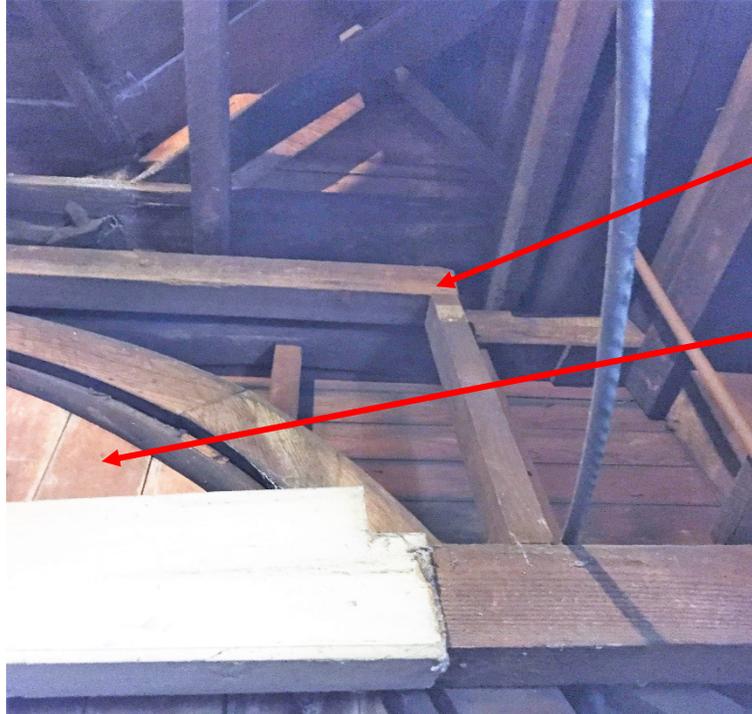
PHOTO #:8

Original
unbraced
support

Clock face

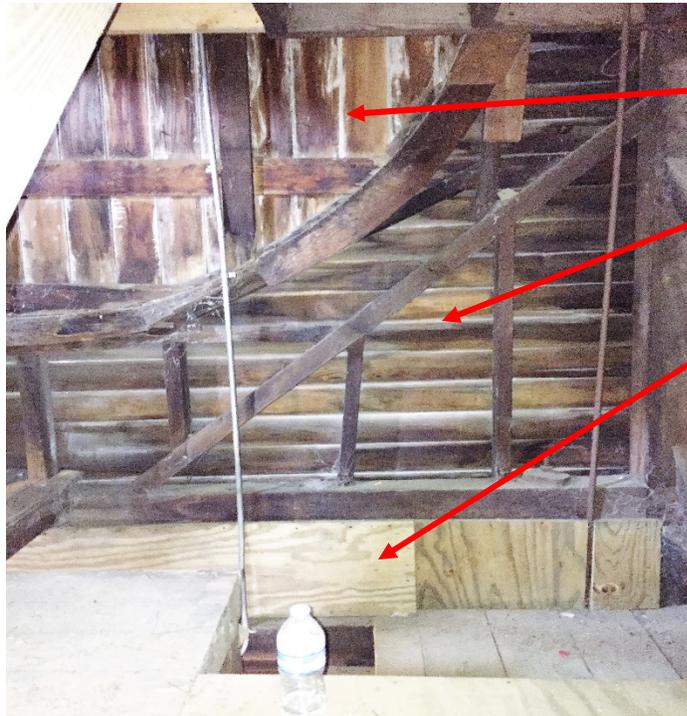
PHOTO #:9

Clock face

Exterior wall

Plywood reinforcement

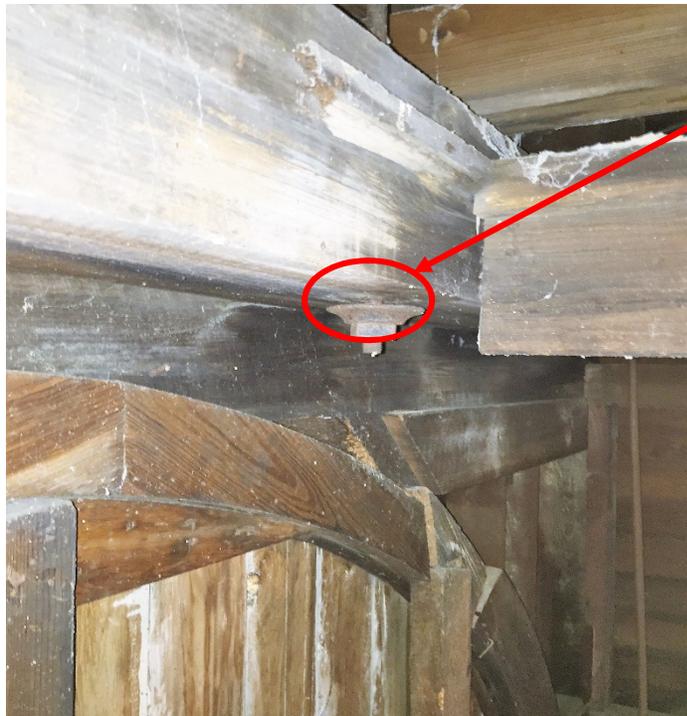
PHOTO #:10

Gapped open joint at rod/washer

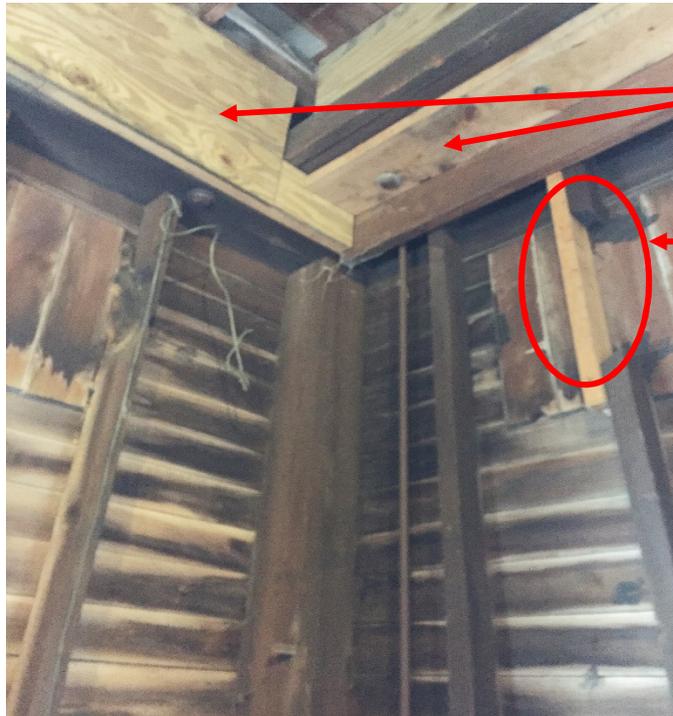
PHOTO #:11

Previous reinforcing

Wall stud splicing

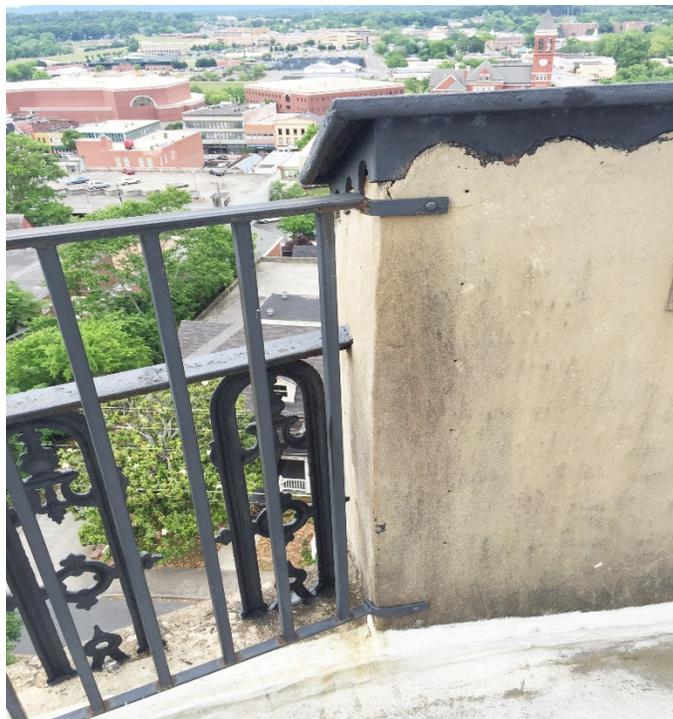
PHOTO #:12

Safety railing at observation level

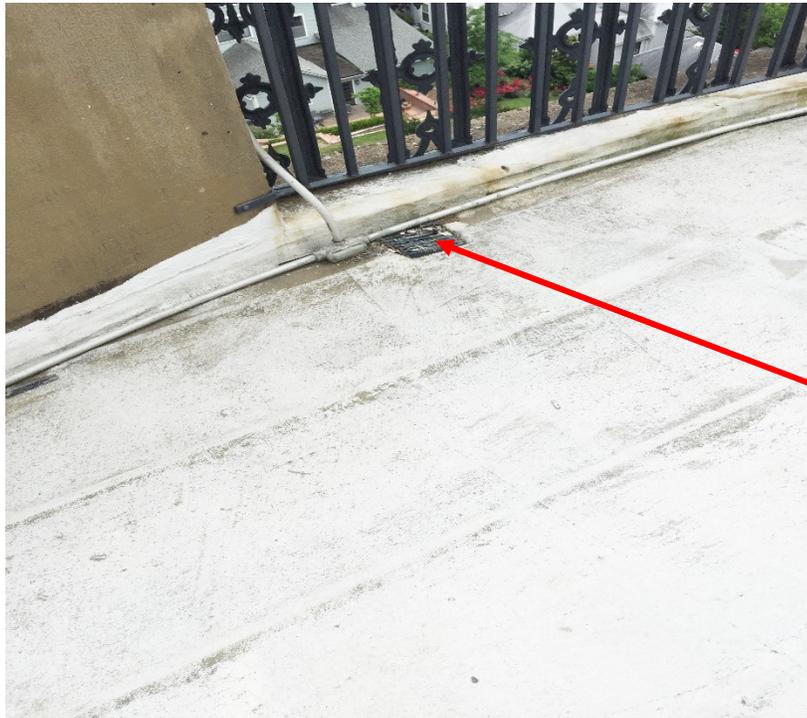
PHOTO #:13

Roof/walking surface at observation level

Roof drain

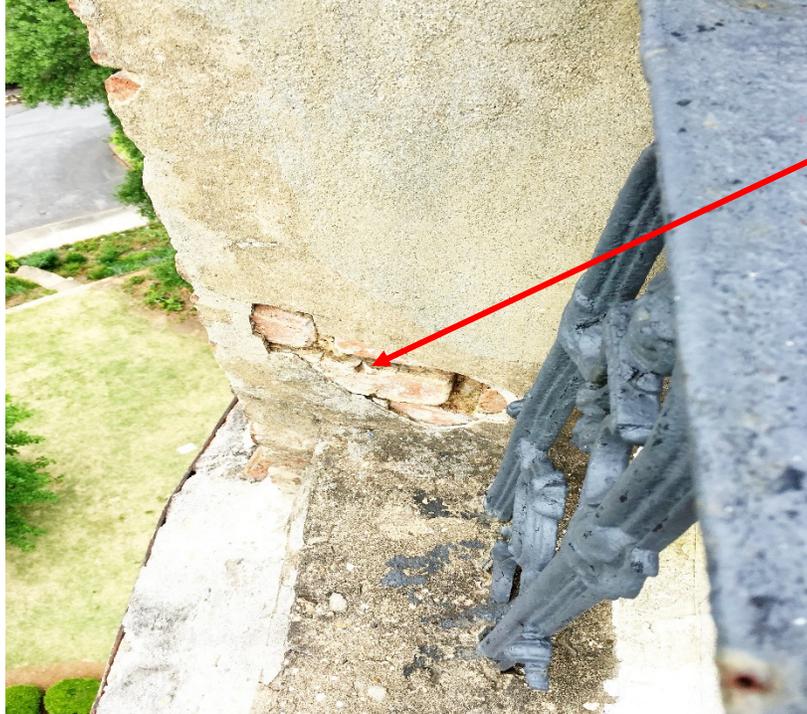
PHOTO #:14

Exposed brick at observation level

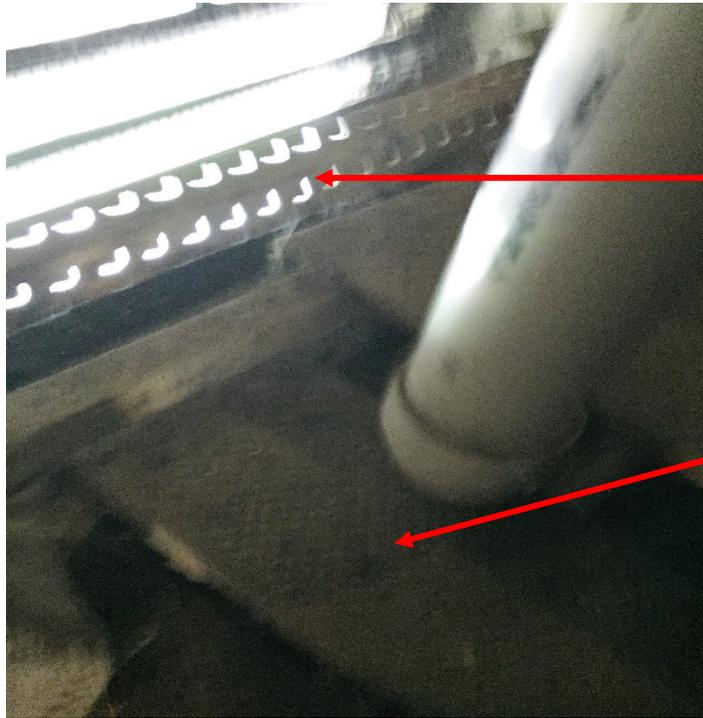
PHOTO #:15

Stair support
across wall
opening

Stair tread
