May 21, 2015

Re: Bruce Hamler Water Treatment Facility
Rome, GA
PEC Project No. F15049

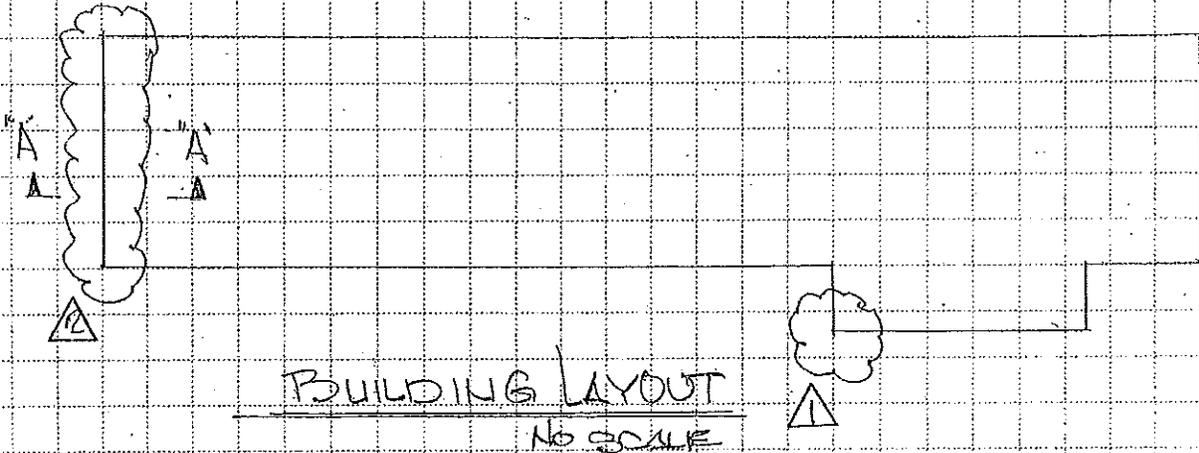
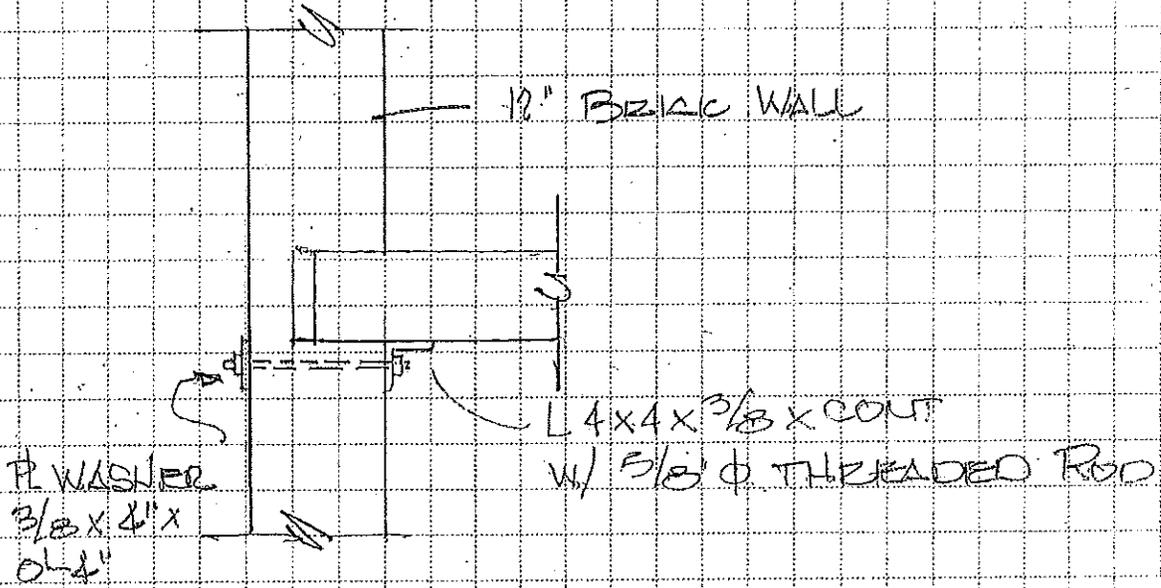
There are two areas that currently need attention. These two areas are clouded on the accompanying sketch. The first one is a stair-step section that has moved out of plane from the rest of the wall in the original portion of the building. The second area is the end wall of the addition where the outside course does not have bond brick tying the outside course to the two inside courses.

The first area is a corner of the initial portion of the building on the first level. It appears as water got into the wall, froze and caused some of the brick to be pushed out plane from the rest of the wall. This area is currently stable but unsightly. I recommend removing these brick that have moved out of plane, drilling and epoxying #3 dowels, 24" long, twelve inches into the existing brick. Drill these into the mortar joints in pairs on twelve inch centers vertically. Re-install the brick and cast stone, bonding them together as were the original brick and install truss type horizontal wall reinforcing (Dur-o-wal) on twelve inch centers.

In the second area, the wall appears to be moving out, away from the rest of the building. This wall provides vertical support for the framed floor. The gap that opened in the floor between the tile and the wall should be monitored. If the gap opens again, indicating continued movement, I recommend further review, but probably piers would need to be added and it could be necessary to reconstruct at least portions of the wall. At this point, I recommend bolting an angle L4x4x3/8 to provide additional support for the slab. See the sketch for a detail.
